CASE HISTORY: COMPARISON OF CSL RESULTS TO PHYSICAL OBSERVATIONS

David S. Graham, P.E., Dan Brown and Associates, 205-427-0682, dgraham@dba.world
Paul J. Axtell, P.E., D.GE, Dan Brown and Associates, 913-744-4988, paxtell@dba.world

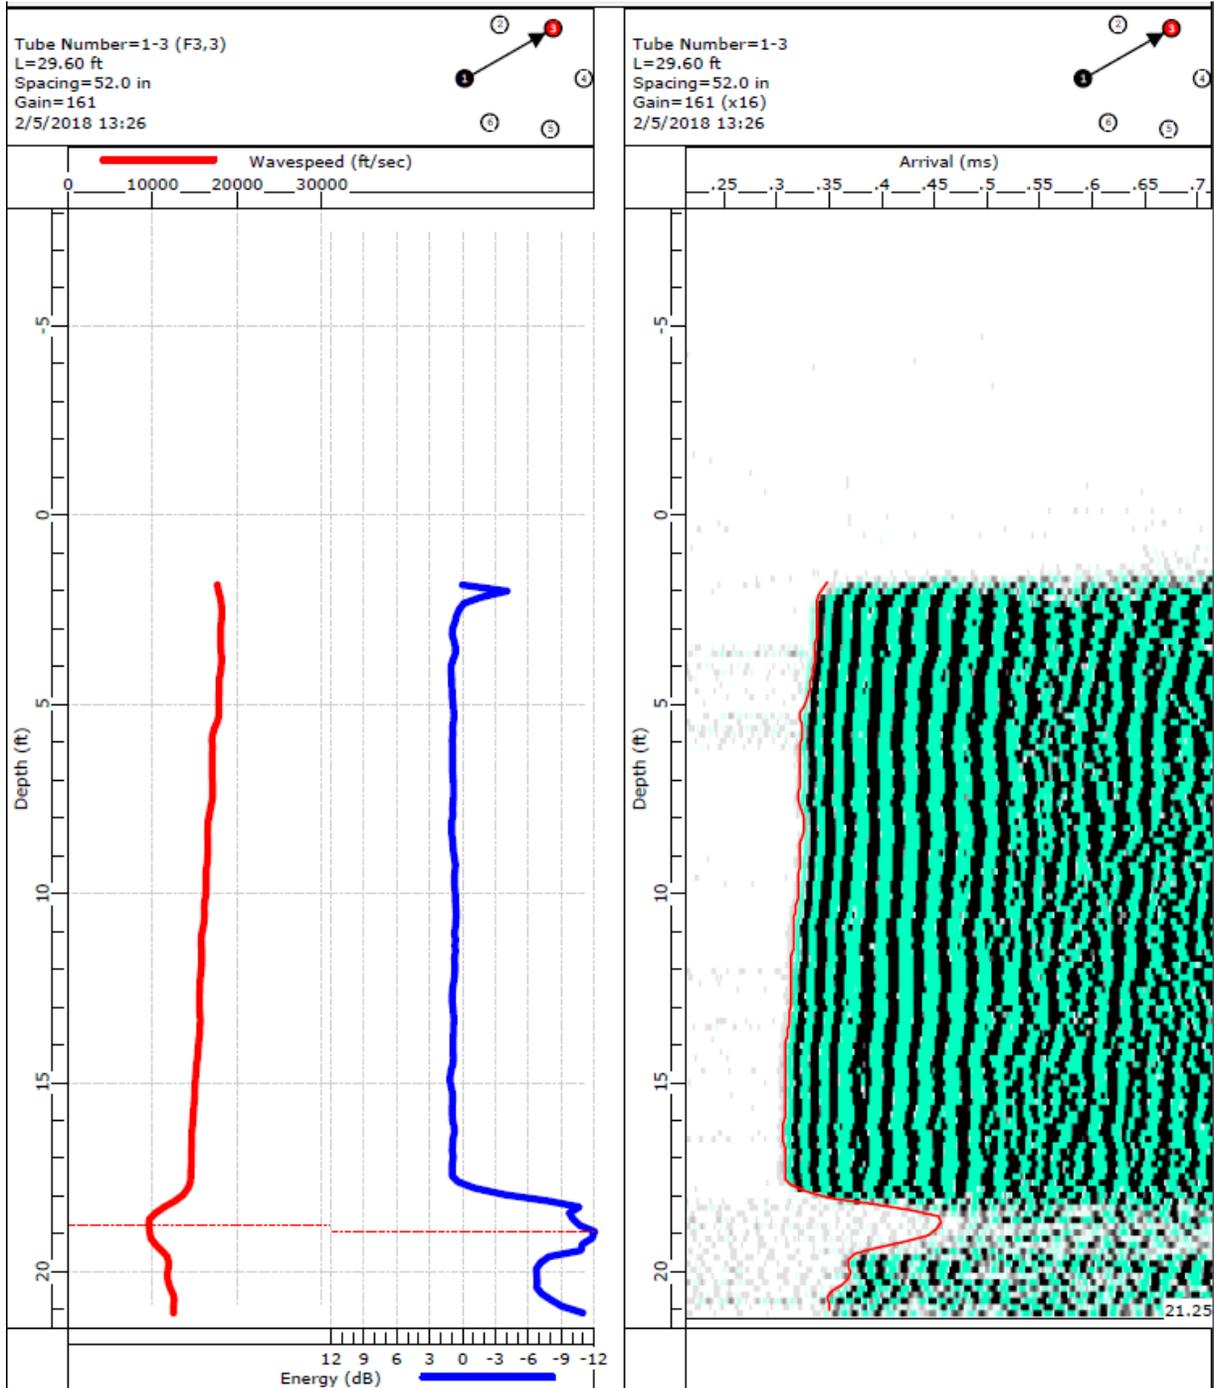
CSL non-destructive integrity testing identified significant anomalous readings in the approximately bottom 4 feet of the rock socket. 13 of 15 CSL tube combinations tested indicated first arrival time (FAT) delays between 14 and 60 percent and energy reductions between 9.5 and 14.7 dB. An example of the CSL results is included in Figure 1. Tomography analysis of the CSL data was not performed at the discretion of the drilled shaft contractor.

Figure 1. Example of typical CSL results.

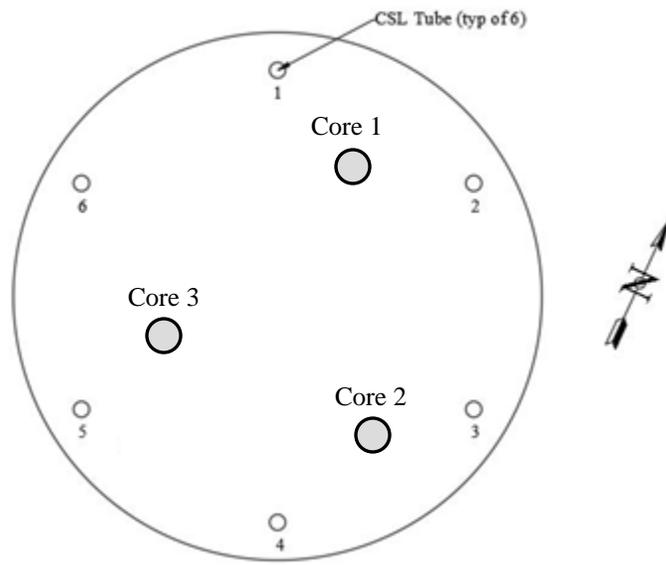
of intercepting the most anomalous readings encountered in the CSL. Core 3 was located on the opposite side of the shaft and was intended to intercept the least anomalous readings encountered in the CSL. The core locations are shown in Figure 2. Cores 1 and 2 confirmed a defect in the anomalous zone in the form of little to no drilling resistance, no concrete recovery, and recovery of sand. Core 3 did not encounter the defect. A submersible camera was inserted in Cores 1 and 2. Sand was observed in the bottom of Core 2. A significant void and exposed reinforcement were observed in Core 1. A screenshot from the Core 1 camera inspection video is included in Figure 3.

Figure 2. Core and CSL tube locations.

Cores 1 and 2 encountered the defect, while Core 3 did not, which also matches well to the physical observations. Had Cores 1 and 2 been performed slightly more towards the center of the shaft, it is unlikely the defect would not have been encountered by any of the cores.

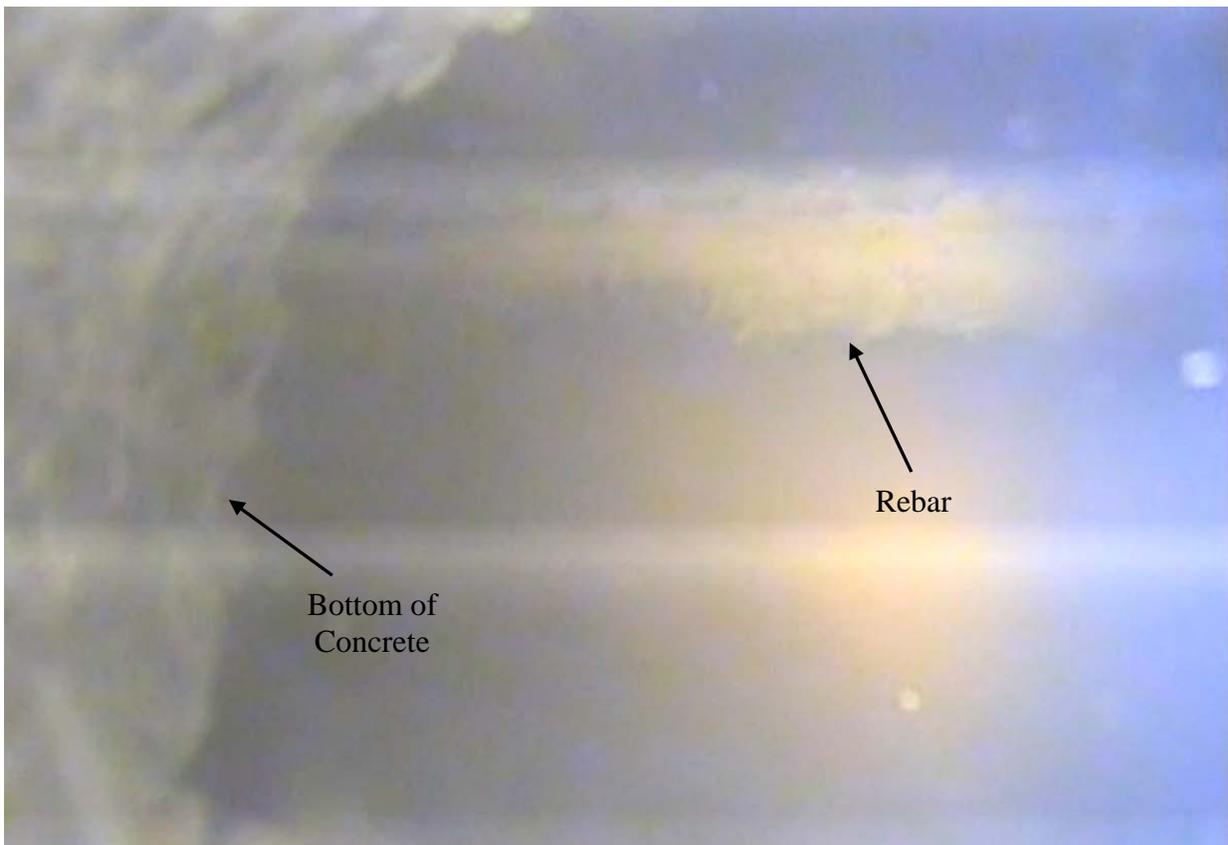
Figure 3. Screenshot from Core 1 camera inspection.

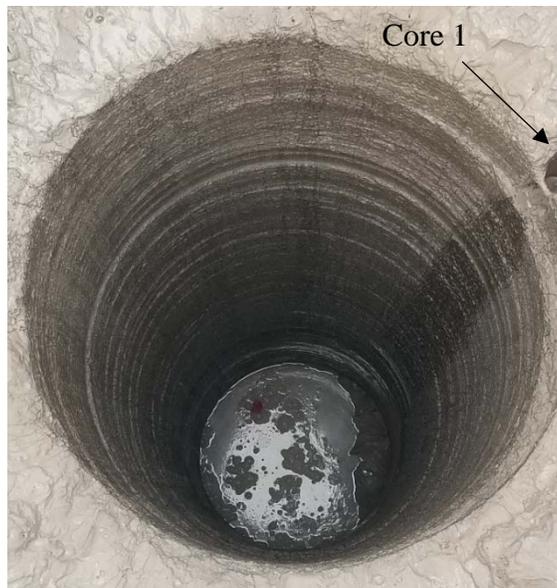
Initially, the center of the shaft was excavated using 3-foot diameter tooling. The hole was advanced to approximately 2 feet above the shaft tip. The hole was advanced in the dry through the upper approximately 12 feet of concrete. Then, the hole was flooded with water and advanced in the wet to prevent sudden hydraulic infiltration upon encountering the anticipated defect. After reaching the target depth, the hole was slowly dewatered in stages to check for hydraulic infiltration. No significant infiltration was observed and the hole was eventually fully dewatered, allowing for direct visual inspection. No defect was observed. A photograph of the dewatered 3-foot diameter hole is included in Figure 4. Note that there was some water seeping out of Core 1 just outside of the 3-ft diameter hole, as can be seen in Figure 4.

Figure 4. 3-ft diameter excavation.

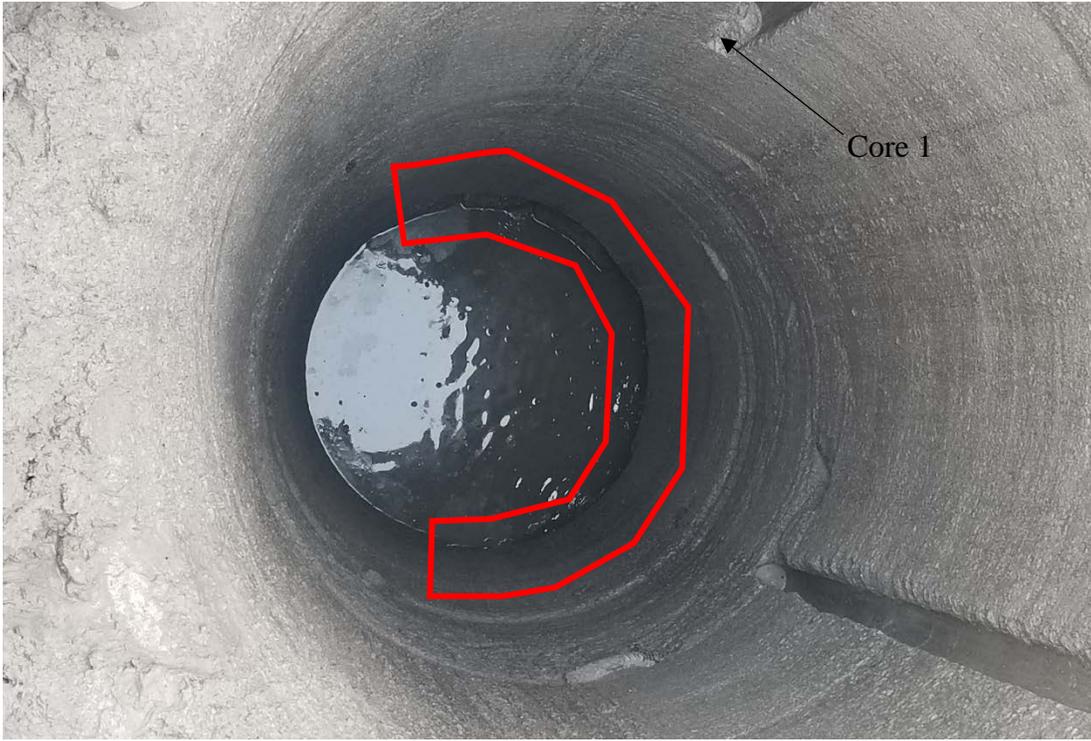
The 3-foot diameter hole was then enlarged using 4-foot diameter tooling in the dry. Upon completion of the diameter expansion, approximately 1.5 foot of water was present in the hole and the top of a void was visible around the circumference of the hole from approximately the 11 o'clock position to the 6 o'clock position, where CSL Tube 1 is the 12 o'clock position (Figure 5). The hole was dewatered as much as possible and visually inspected with a camera (Figure 6). On the basis of the visual observations, pieces of concrete of unknown quality were trapped between the reinforcement cage and wall of the rock socket. Vertically, the top of the void was approximately 4.1 feet above the base of the socket.

Figure 5. 4-ft diameter excavation, visible void outlined in red.

To remediate the shaft, a 30.5-foot long, 4-foot diameter socket was extended below the tip of the existing shaft. The new socket replaced the axial side and base resistance provided by the bottom 5-feet of existing 6.5-foot diameter socket, which was neglected for remedial design. The remedial socket included a reinforcing cage with 4 CSL tubes designed by the project's structural designer. The remedial socket was drilled and poured using typical procedures for the project's drilled shafts.

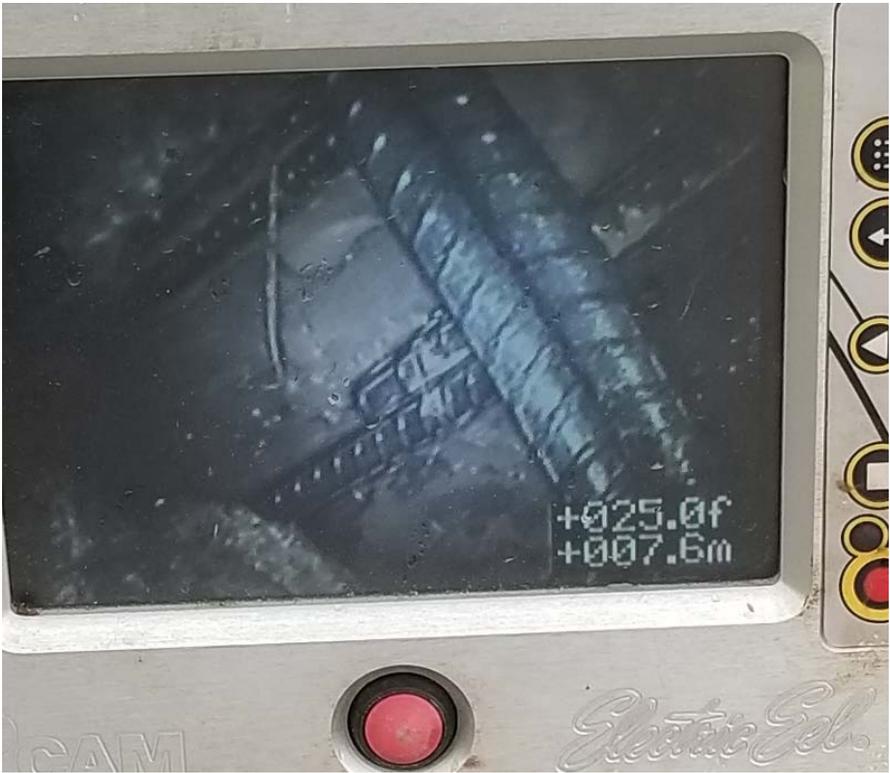
Figure 6. Camera inspection of side wall, exposed rebar visible.

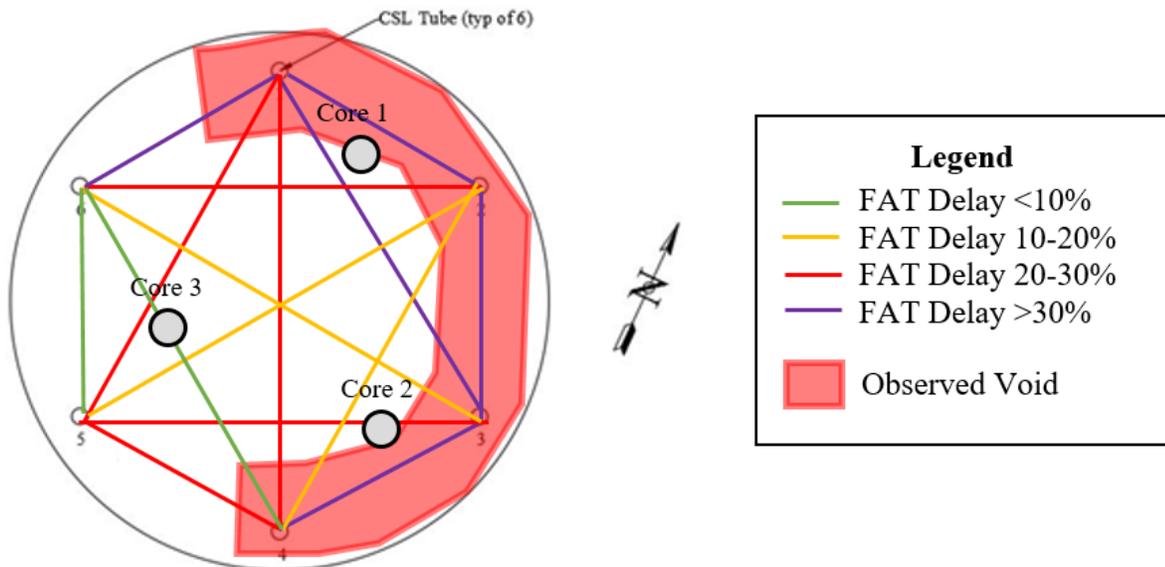
Good agreement exists between the void observed in the 4-foot diameter excavation and the CSL results. This is shown in Figure 7 by comparing the maximum FAT delays between tube pairs and the observed void from Figure 5 super-imposed on the CSL results. Note that from the physical observations, the defect is primarily around outside of the shaft, as the 3-foot diameter excavation did not encounter the defect. Despite the defect being in the zone where CSL is often considered ineffective, CSL successfully detected the defect in this case. Although the results well match the physical observations, it was difficult to predict the nature and extent of the defect from CSL alone. Possibly, tomography analysis of the CSL data would have provided a better prediction of the extent and location of the defect. From the perspective of the drilling contractor, tomography analysis was unlikely to result in reduced remedial cost and was therefore not performed.

Figure 7. FAT delays with overlay of observed void from Figure 5.

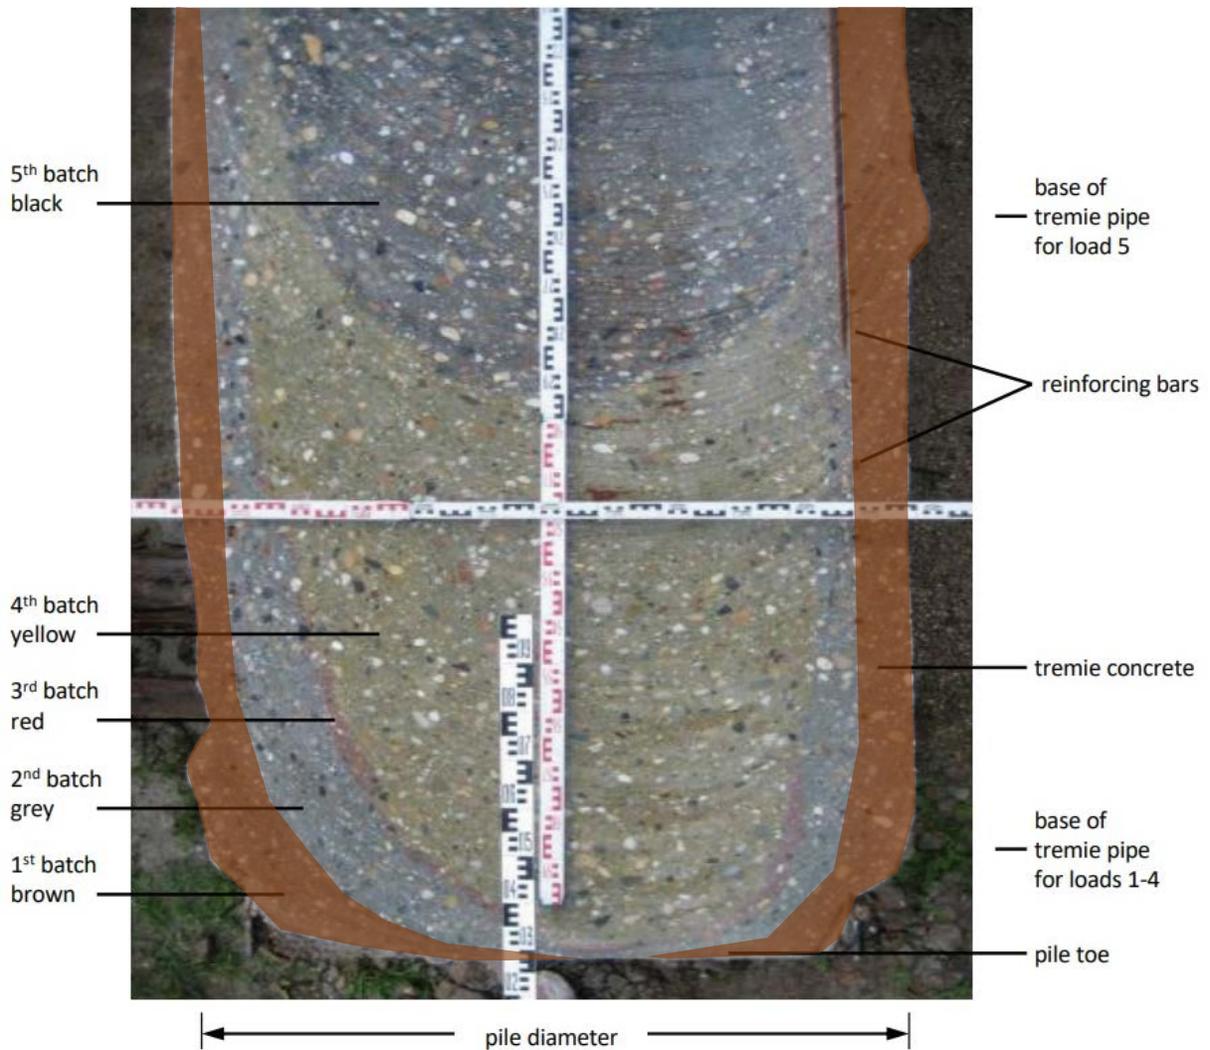
The defect is believed to be the result of either a significant amount of loose material at the base at the onset of concrete placement or mixing of the first load of concrete with water in the shaft. There is no indication in the construction records as to the cause of the defect; however, the location of the defect around the outside of the shaft near the base suggests an issue at the onset of concrete placement based on documented fluid concrete flow patterns (Böhle and Pulsfort 2014 and Brown, Bailey, and Schindler 2005) and numerical modeling of concrete flow (Beckhaus et al 2018). The brown colored (1st batch) concrete in Figure 8 from Böhle and Pulsfort (2014) illustrates this point.

Figure 8. Cross section of a drilled shaft placed with dyed loads of concrete, first batch (highlighted in brown for clarity) approximately corresponded to the location of the defect observed at the case history shaft (Böhle and Pulsfort 2014).
