The Unexpected Consequences of a Small Side-Hill Fill

ABSTRACT: In late 2014, the Minnesota Department of Transportation repaired a highway embankment in Little Canada, MN. The embankment is 30-ft in height, and had been in operation for several decades, showing no signs of distress prior to a reconstruction project in 2006. As part of the 2006 corridor improvement project, additional fill was placed on the west side slope adjacent to the existing embankment section of interest. The modest amount of new fill caused unintended distress almost immediately after the new asphalt roadway shoulder was paved. Following construction, ongoing settlement and surface cracking in the asphalt shoulder required regular maintenance and patching. The recurring pavement distress and maintenance needs led to a remediation project, construction of which started in August of 2014. Plausible causes of the continued deformation were identified as: marginal embankment stability, low resistance to lateral squeeze, and consolidation under the stresses imposed by the embankment. The design challenge was to devise a successful remediation method capable of addressing all three possible sources of deformatio

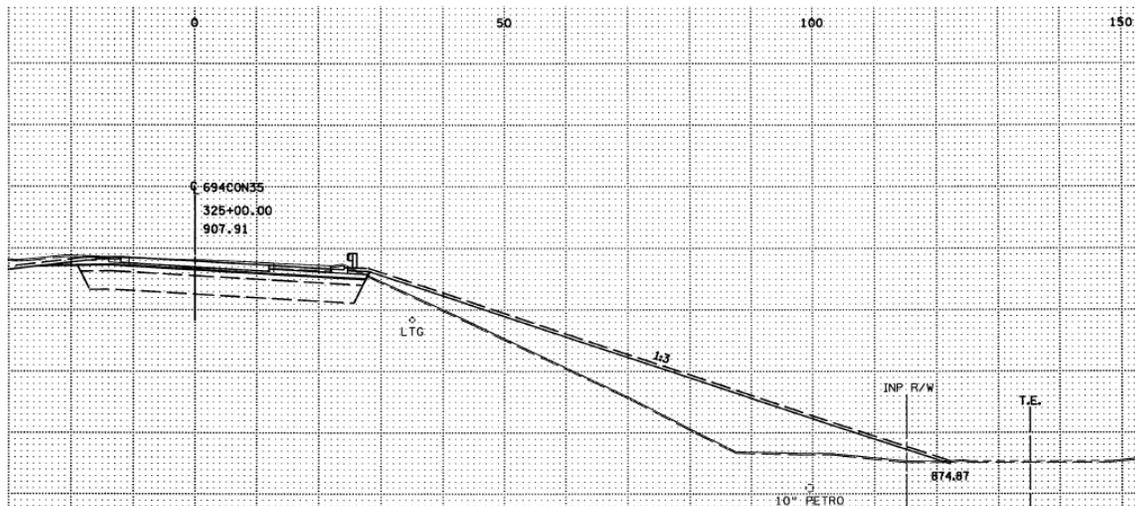
In the embankment section of interest, just to the south of Bridge 62914, the embankment base was designed for a widening of about 35 feet with a maximum amount of new fill of about 10 feet in height, being placed at the former embankment toe. This added fill was to flatten the slope from the in-place condition to create a 1V:3H slope. At some point, perhaps when the new fill began to encroach on a wetland area to the west, the extent of the fill appears to have been adjusted. The actual in-place fill is about one-half the intended design fill with a widening of only about 10 feet to 15 feet at the base with a corresponding maximum added height of about 5 feet. Prior to this project no signs of roadway distress had been documented. The modest amount of new side-hill fill began causing distress to the bituminous roadway shoulder at the top of the slope as the reconstruction project neared completion in the spring of 2008. A dip of several inches in the asphalt shoulder was observed shortly after it was placed, with large cracks extending from the Bridge 62914 approach panel area (the southern approach panel had not yet been placed) across the shoulder paving to the newly installed concrete curb.

Figure 1. New construction widened the roadway embankment to the west. The toe was extended about 10 feet toward a wetland area flattening the existing slope to a 1H:3V condition. The actual fill placed during the project was only about half of the fill shown in the design drawing (shown).

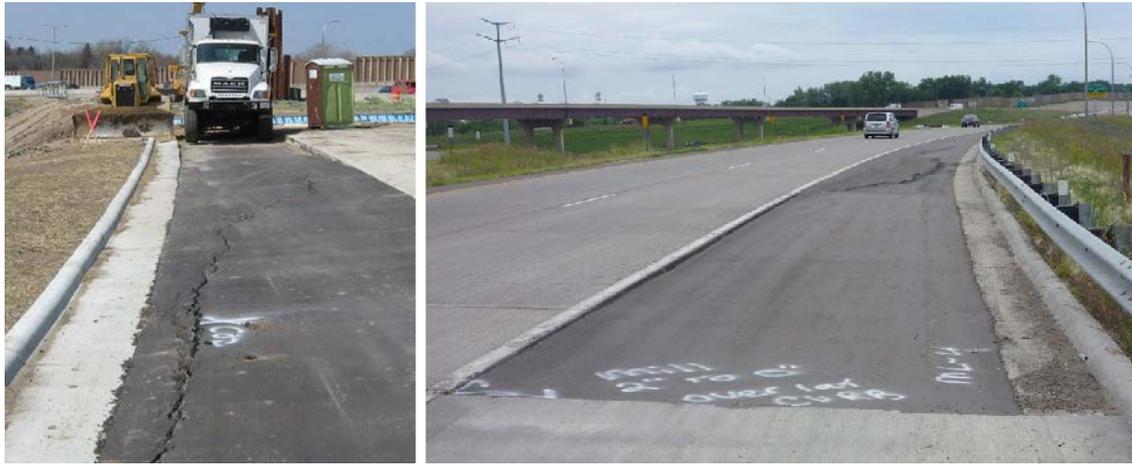
Following the 2006-2008 construction activities, ongoing settlement and surface cracking in the asphalt shoulder required regular maintenance and patching to ensure safety to motorists. Each time more asphalt was added to the area to cover the cracks and fill in the depression, similar cracking and settlement would repeat. The recurring pavement distress and regular maintenance requirements led to the design of a remediation project in 2011; construction was started in August of 2014. Figure 2 shows the distress observed during construction in the spring of 2008 and subsequent distress, after multiple patching activities, in June of 2010.

Figure 2. Distress cracks in the bituminous shoulder were seen during construction shortly after the bituminous shoulder was placed (left) in April 2008. New distress is seen (right) in June 2010.

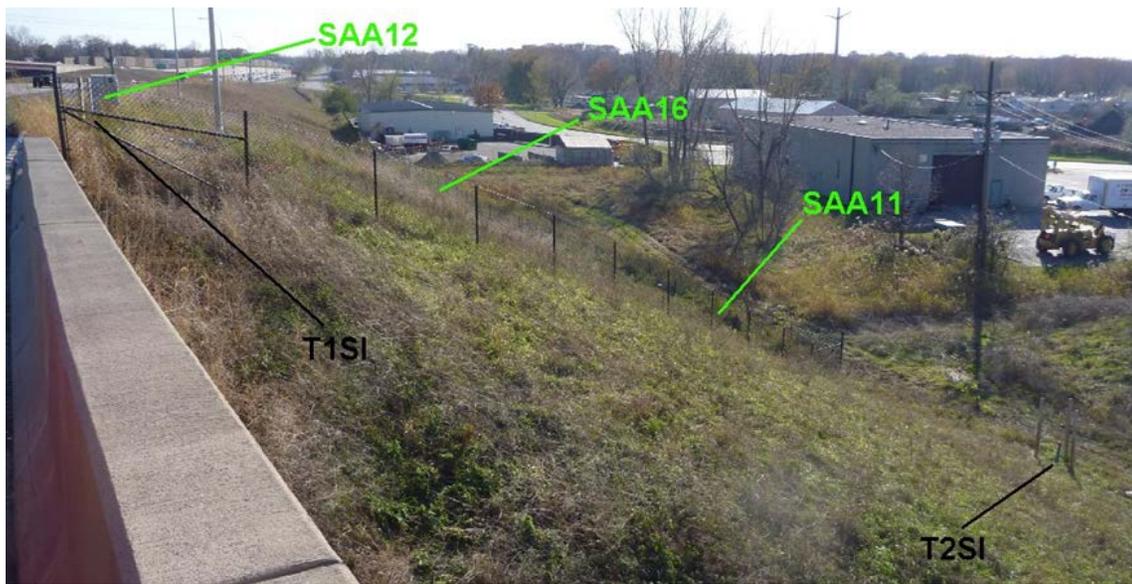
The two inclinometers would reveal within the first year of surveys that there was lateral movement both at the crest of the embankment and the embankment toe. In the first year of monitoring at T1SI, at the crest, movement of 2 inches was observed, originating at a depth of about 40 feet within the sandy loam material above the softer cohesive soils which were encountered at a depth of 60 feet below the roadway shoulder. Also in the first year of observation, inclinometer T2SI, at the toe of the embankment, also showed about 2 inches of cumulative

movement. Here, the deformation started at a depth of about 50 feet, which coincided with the depth of the soft silty clay soils.

The SAA sensor results agree with the traversing probe information and show that the embankment is slowly deforming and moving toward the west. In general the movement can be described as tilting rather than slipping; the upper soil layers appear to be deforming with small displacements throughout the embankment rather than shearing along a well-defined plane.

Figure 3. The embankment fill is shown looking southwest from the adjacent bridge. T1SI and T2SI are borings with slotted casing for manual traversing probe inclinometer use. Installations SAA11, SAA12, and SAA 16 are outfitted with automated ShapeAccelArray sensors.

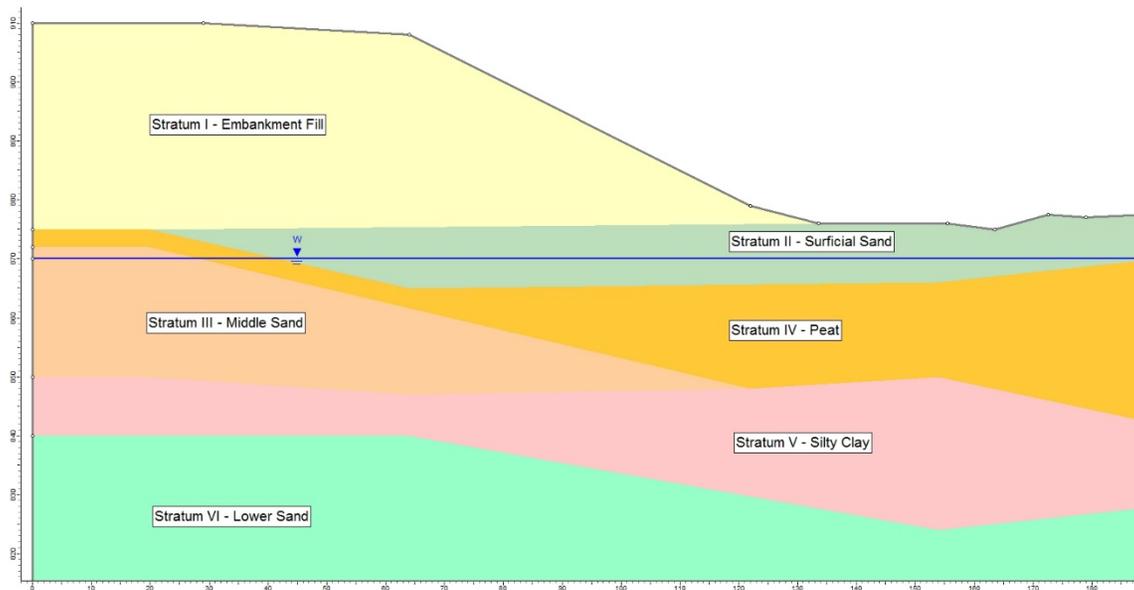
Figure 4. General Slope Stability Model Stratigraphy.

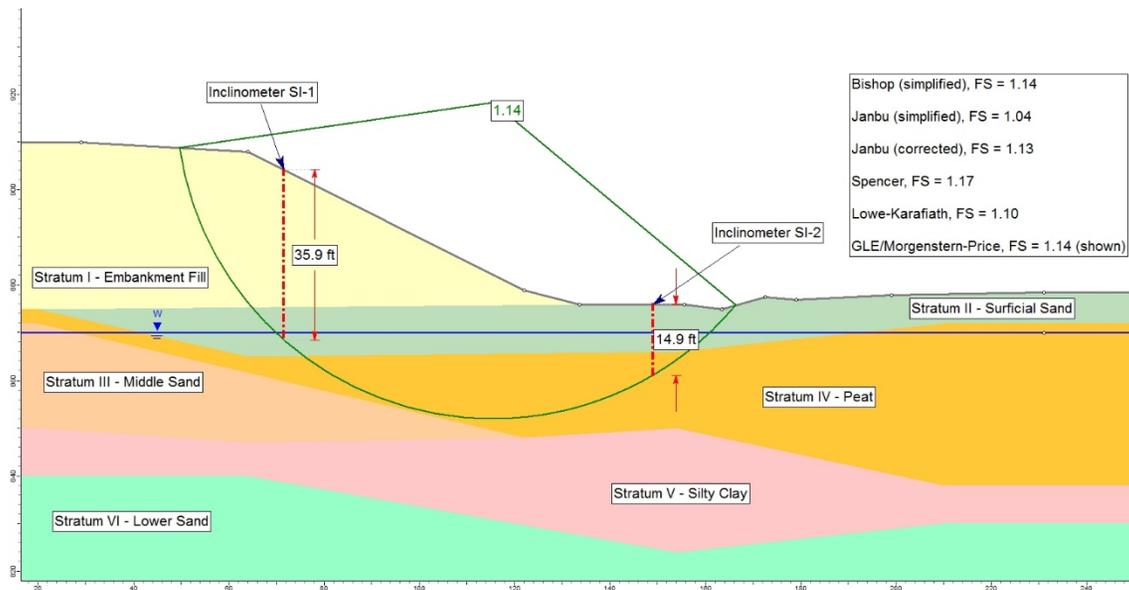
Also shown in Figure 5 are the locations of two manual inclinometers, T1SI and T2SI (dashed lines), the critical shear circle determined from analysis of the existing condition, and the contour plot of the safety factor associated with the position of the trial radii. By inspection of the inclinometer displacement plots, good agreement exists between the predicted and measured location of the shear surface, supporting the appropriateness of the model for the existing condition. Distress cracking observed in the bituminous shoulder at the crest of the slope is also consistent with the critical shear surface, further supporting the model's parameters and results.

Figure 5. A Minimum Factor of Safety of 1.14 was obtained for the existing embankment condition based on the geometry and material parameters used to represent the site (for Morgenstern and Price's Method).

Results of these slope stability calculations indicate a marginally stable slope with a computed factor of safety of about 1.1. Therefore, utilizing a limit equilibrium approach, a failure (e.g., a factor of safety less than unity) is not predicted for the modeled conditions, consistent with the field conditions where a complete failure has not been observed. At low computed slope factors of safety, less than about 1.3, problematic deformations frequently occur. The minimum computed factors of safety from the soil models appear consistent with the ongoing deformation.

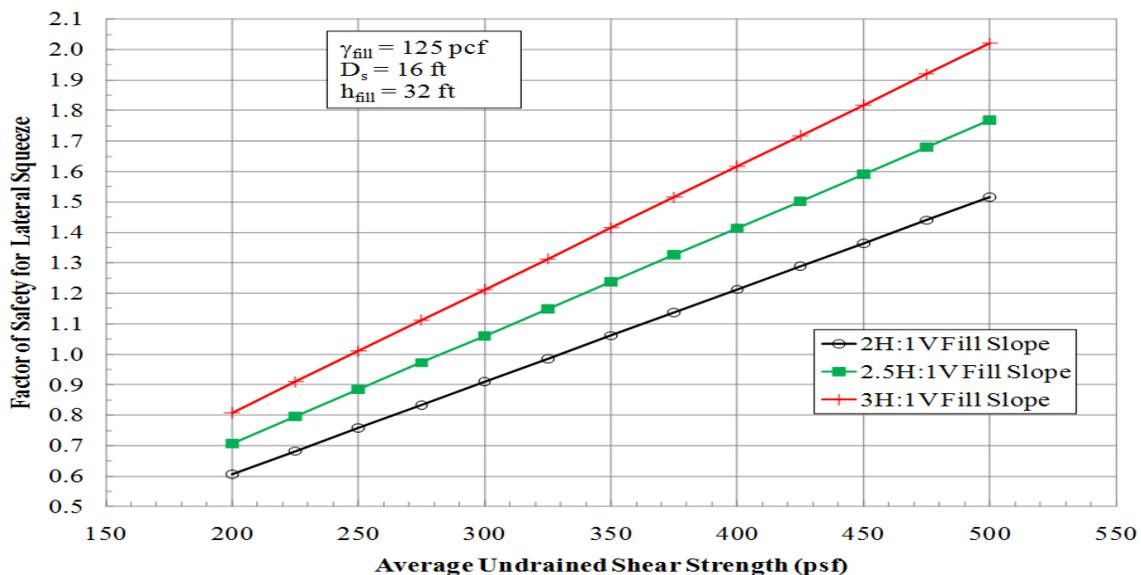
Figure 6. Stratum IV Peat Lateral Squeeze Evaluation Chart

The 2H:1V data series indicates that for FS_{SQ} equal to unity, s_u is about 330 psf, noting when FS_{SQ} approaches unity intolerable deformation should be anticipated. The 2H:1V data series indicates that for FS_{SQ} equal to 1.3, s_u is about 430 psf. The average s_u in the peat may be low; more likely the peat itself is not particularly stiff leading to bulk deformation and lateral squeeze as a second probable mechanism promoting the observed deformation.

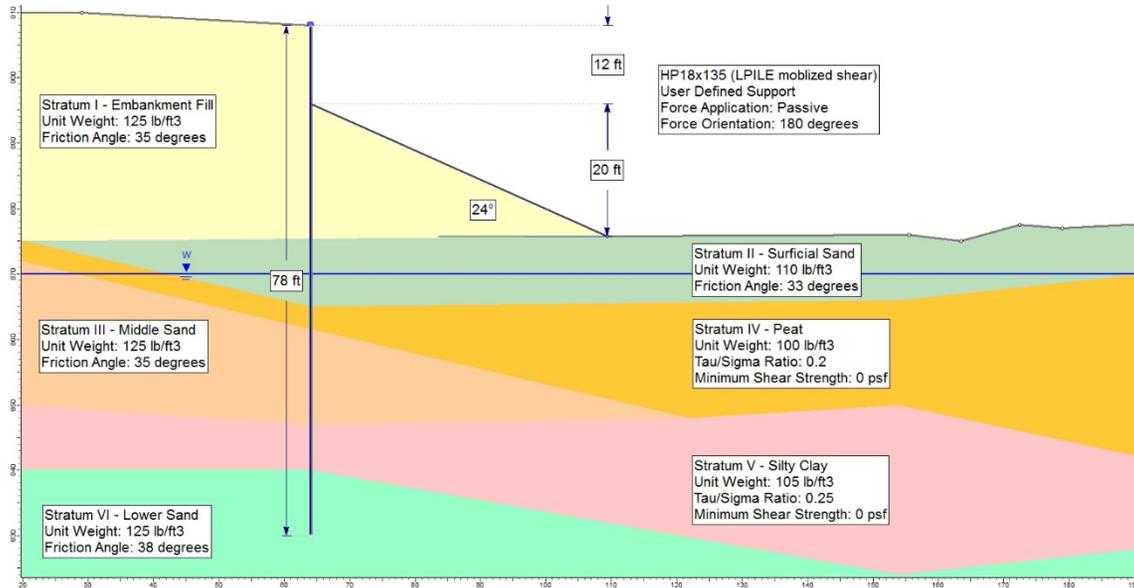
Figure 7. Slope stability model adapted to the mitigation strategy applying both soil unloading and a wall.

Global slope stability was analyzed for a 12 ft retained height using the soil properties established from evaluation of the existing condition. Those properties are provided in Table 1 and shown in Figure 7, along with the modeled geometry and layering. Note that modeling the shear strength in Stratum IV and V as a ratio of the effective vertical stress is slightly conservative considering an appreciable portion of the existing embankment will be excavated. The resulting reduction in effective vertical stress serves to reduce the shear strength beneath the excavated zone despite the fact that the soil now has been exposed to larger stresses. However, the minimum shear surfaces after remediation tend to develop in the embankment, so this slightly conservative modeling has little effect on the results of the analyses. The resistance provided by the HP18x135 soldier piles was manually included in the SLIDE analysis by determining the magnitude of shear force that can be mobilized in the piles. This mobilized shear force is primarily governed by geotechnical resistance as well as deflection of the pile and is substantially less than the shear capacity of the structural section. The magnitude of the mobilized shear was determined at several depths using the LPILE model under Service Limit State loading.

To determine the mobilized shear force at each depth interval in LPILE, the soil movement function was activated, which allows the pile to be loaded by moving soil at user-specified depth intervals. The amount of soil movement was set at 4 inches, which when applied to a depth of 57 ft beneath the pile head, resulted in the bending moment in the pile approaching the flexural capacity of the structural section. The resulting mobilized shear at a depth of 57 ft was 329 kips. When applied over the 5 ft center-to-center spacing, and for user-specified input into SLIDE, the shear resistance provided by the pile at that depth became 65.8 k/ft.

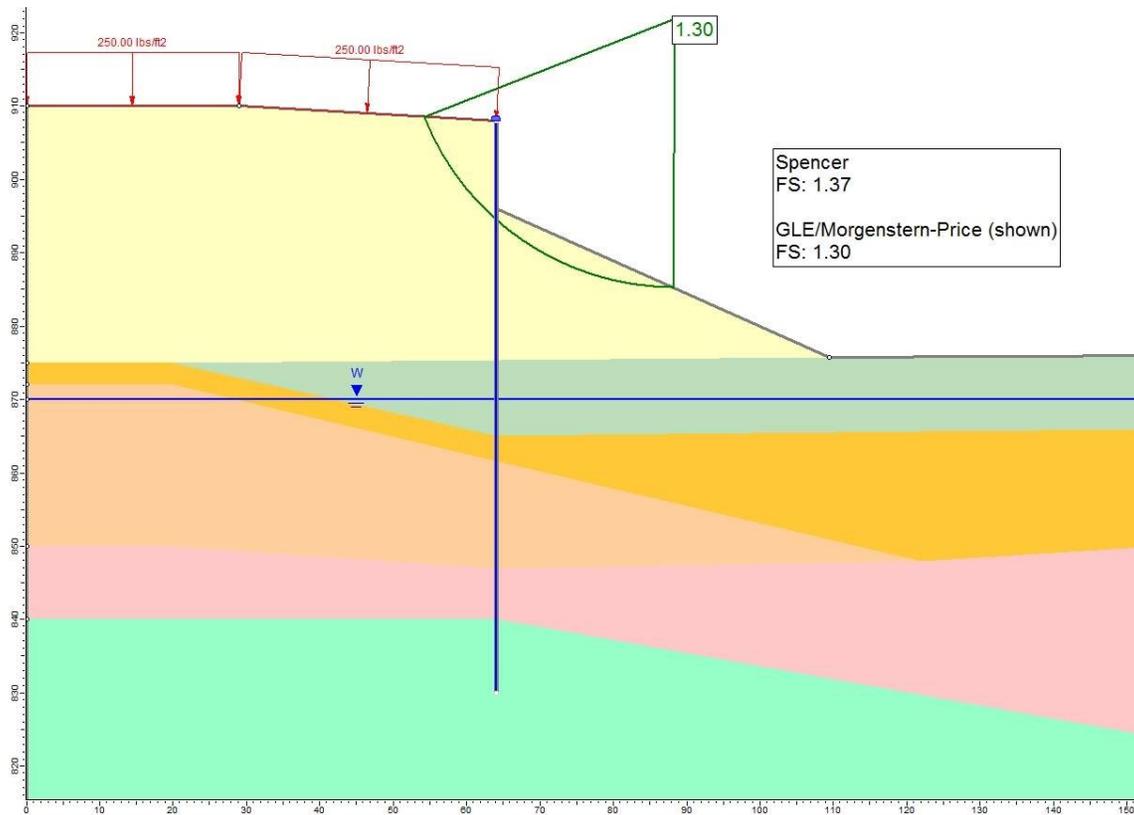
Figure 8. Global stability for remediated embankment section with 250 psf live load.

Global stability was evaluated both for no external load and for a 250 psf live load (traffic) surcharge per FHWA guidelines. Stability was evaluated without the live load surcharge to quantify the increase in limit equilibrium slope stability provided by this remediation system as compared to the existing condition. Only the Spencer's and Morgenstern and Price's methods were used to analyze the remediated section as these methods are believed to yield the most accurate results, especially when including the soldier piles. Results of analyses using the Spencer's and Morgenstern and Price's methods are shown in Figure 8 for the live load surcharge case. Slope stability calculations indicate a stable slope with a computed factor of safety of about 1.5 under no external load, a substantial increase over the factor of safety for the existing condition of about 1.1. The minimum computed factor of safety under the 250 psf live load surcharge is about 1.3. Note that these factors of safety correspond to a 12 ft retained height, although a 9ft retained height was planned. Factors of safety were determined to be acceptable.
