## **THE USE OF SELF-CONSOLIDATING CONCRETE FOR DRILLED SHAFT CONSTRUCTION: PRELIMINARY OBSERVATIONS FROM THE LUMBER RIVER BRIDGE FIELD TRIALS**

**ABSTRACT:** Several drilled shafts have been constructed using self-consolidating concrete (commonly referred to as “SCC”) as part of a field trial with this material. Identical shafts were constructed with a concrete mix typically used in coastal South Carolina. Although the project is ongoing at the time of this writing, the preliminary observations of the performance of the concrete during construction provides insight into the behavior of tremie-placed concrete. Both mixes were observed to have excellent workability characteristics. The observations of the hardened concrete from recovered drilled shafts provide indicate that generally good performance can be achieved in difficult construction conditions (congested cage, tremie placement, lengthy placement times) if highly workable concrete is utilized. Some imperfections in the concrete were observed even under these closely monitored conditions, and some degree of imperfection in this type of construction appears to be practically unavoidable. The imperfections observed in these fi

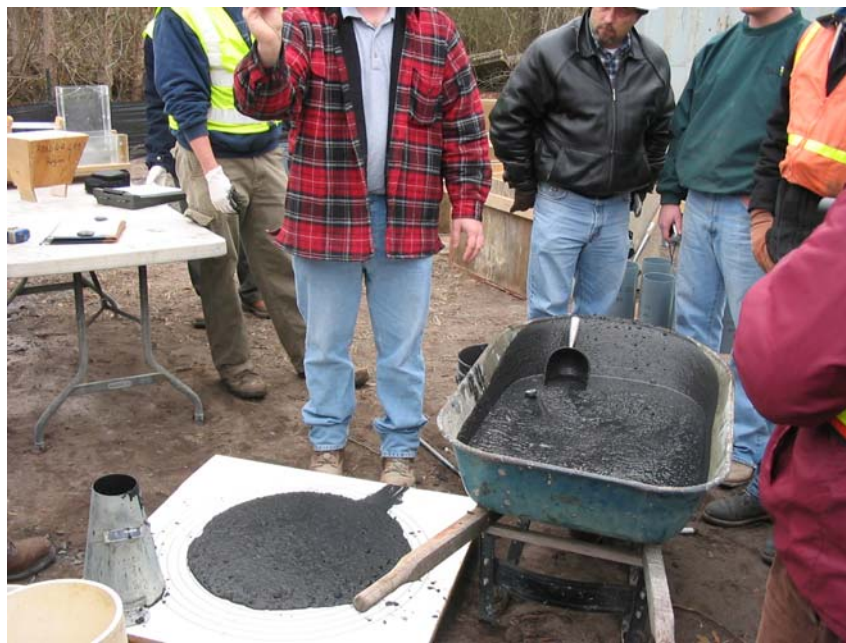
**Figure 1 Slump Flow Test on SCC (Concrete is Colored Black)**

- 3) The SCC mix workability characteristics are based on a measurement of slump flow rather than slump. Slump flow is determined by placing the mix within a conventional slump cone (without rodding) on a plexiglass surface, then withdrawing the slump cone and measuring the diameter of the resulting concrete “pie” as shown on Figure 1. The target for this project was a slump flow of 21 inches, +/- 3 inches, but the actual slump flow as indicated on Table 1 was slightly higher than the target value.

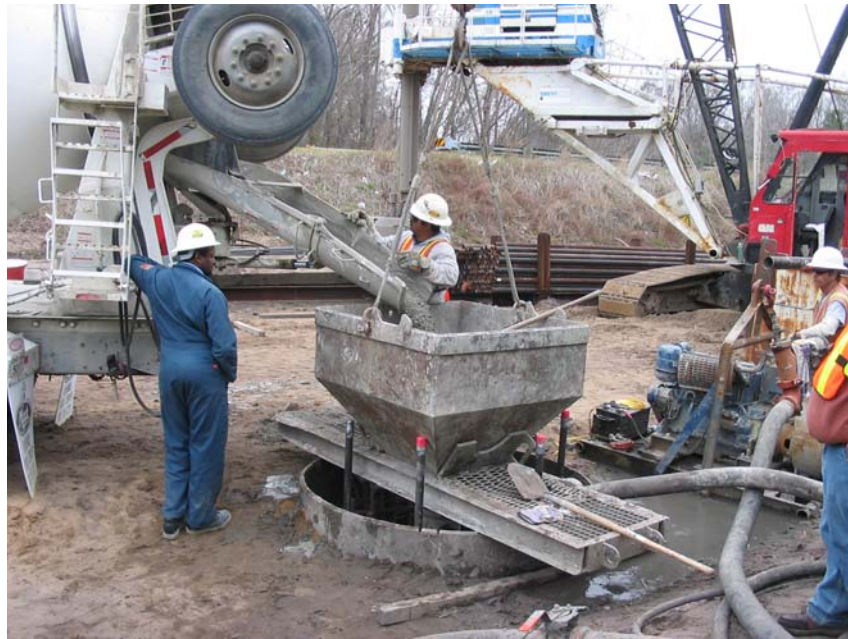
Figure 2 Tremie Placement of Concrete

After drilling and cleaning the shaft excavation, the concrete was placed via a 12 inch diameter segmental tremie pipe. The tremie was placed into the hole as an open tube and concrete flow initiated through the tube using a traveling plug. The traveling plug was a foam ball which had been saturated with water prior to use. The tremie was maintained at least 10 feet into the concrete at all times; concrete was placed with the tremie held stationary until the concrete was 20 feet above the tremie discharge end, then the tremie was lifted and a 10 foot section removed. After completion of the shaft, the temporary casing was removed using a vibratory hammer.

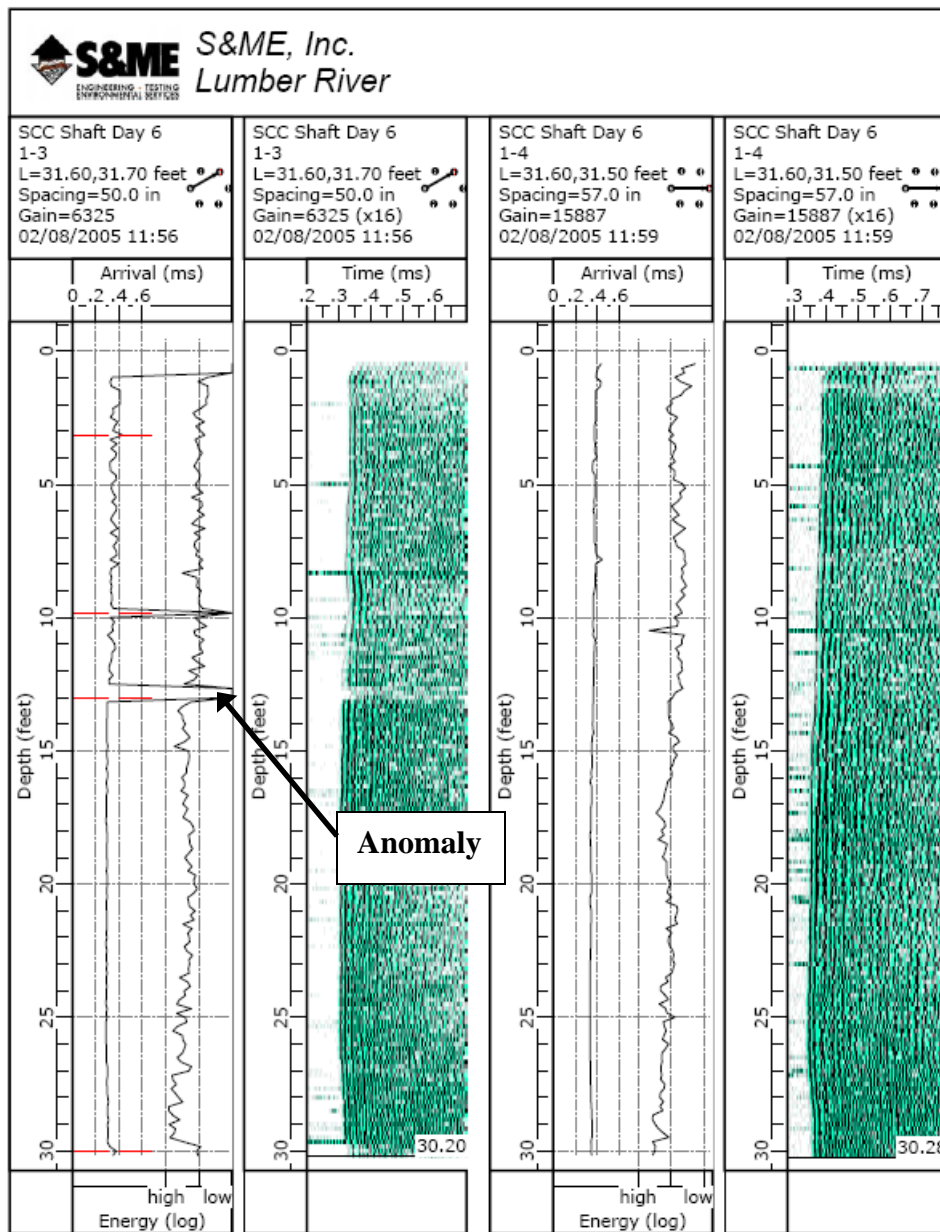
**Figure 3 CSL Test Data from SCC Experimental Shaft**

All of the shafts were subject to integrity testing using crosshole sonic logging (CSL) via the 6 metal tubes. CSL tests were typically performed 6 to 8 days after casting, at which time concrete compressive strengths from cylinders were in excess of 3300 psi. The experimental shaft cast with the SCC mix had an indication of a significant anomaly at the 13 foot depth as indicated on Figure 3. This measurement indicated 100% loss of signal between tube 3 and several other tubes. Smaller loss of signal in the range of 25% to 64% was indicated in the 9.5 to 10 foot depth range at some locations in this shaft.

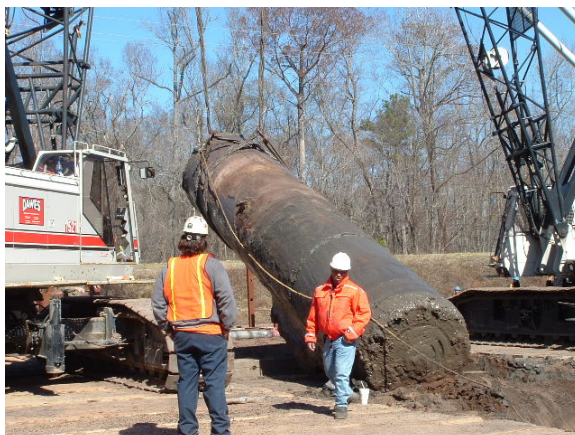
**Figure 4 Exhuming Shaft**

After completion of the CSL testing, the two experimental shafts were exhumed for further examination. The exhumed shafts were pressure washed and cut at select locations using a wire saw. Cuts were made across the diameter of the shafts at depths of 6 feet from the base and 13 feet from the top (corresponding to the location of the most significant anomaly). Both the bottom 6 foot long segment and the top 13 foot long segment were then cut longitudinally through the center, with the cut centered across the shaft through tube numbers 3 and 6. Photographs of the entire operation are shown on Figures 4 through 12.

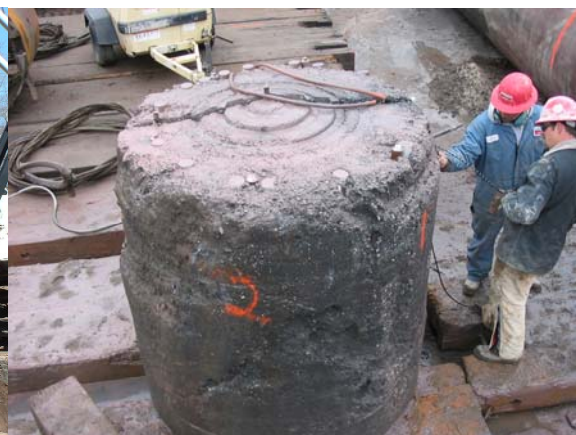
**Figure 5 Shaft Base (Bottom 6 feet)**

The exterior surface of both shafts looked excellent, with no appearance of surface irregularities even at the location of anomalies from the CSL data. The bottoms of the shafts showed the pattern left by the clean-out bucket as shown on Figure 5. There were some irregularities around the perimeter of the base of the shafts. According to the inspector on the job, the bottom hole sounding appeared somewhat cleaner on the excavation corresponding to the SC coastal mix shaft although his judgment was that both shafts were within acceptable tolerance for cleanliness according to typical construction in South Carolina.

- 1) The base cleaning process appeared to provide an adequate cleaning of the shaft excavation at this site, even with inspection only performed by sounding in lieu of bottom hole camera inspection.

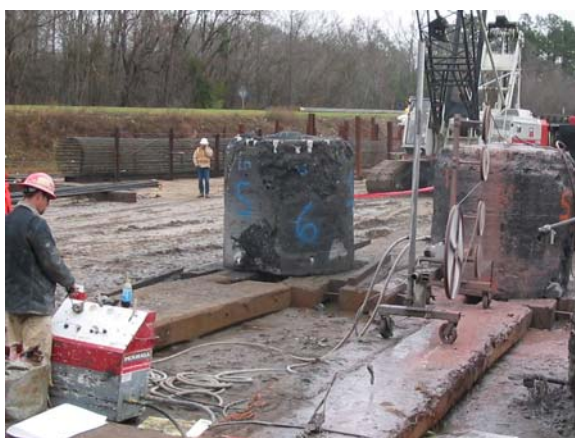
**Figure 6 Wire Saw Operation**

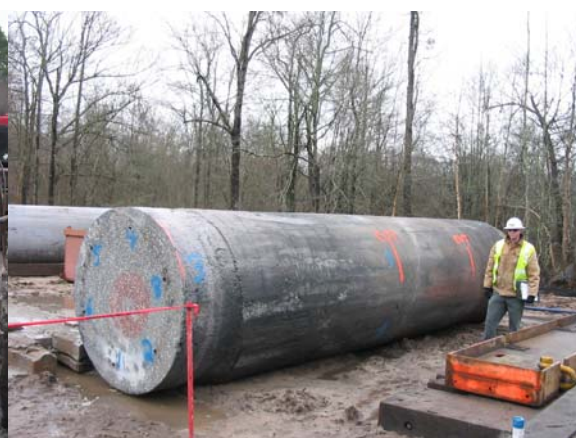
**Figure 7 SCC Shaft after First Cut**

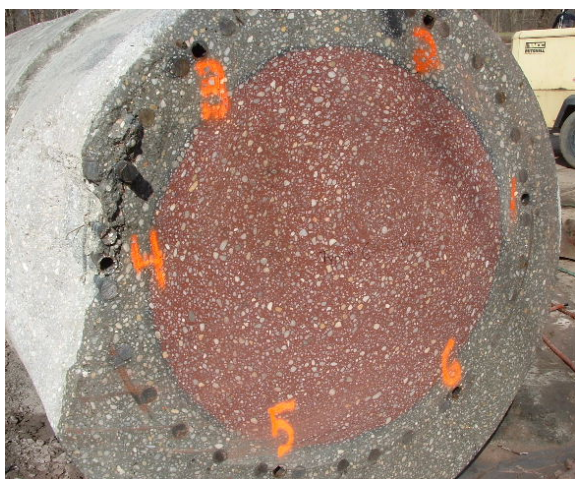
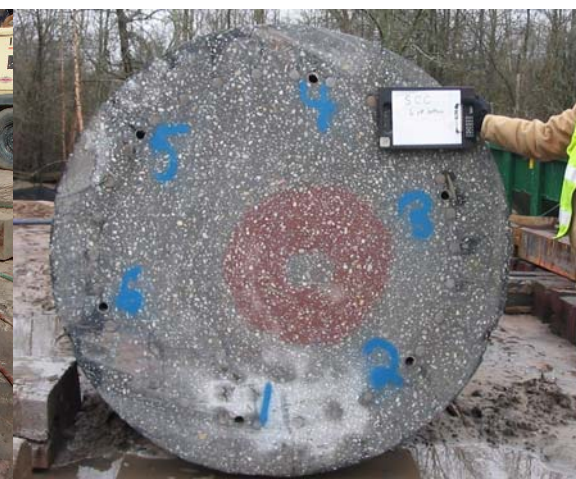
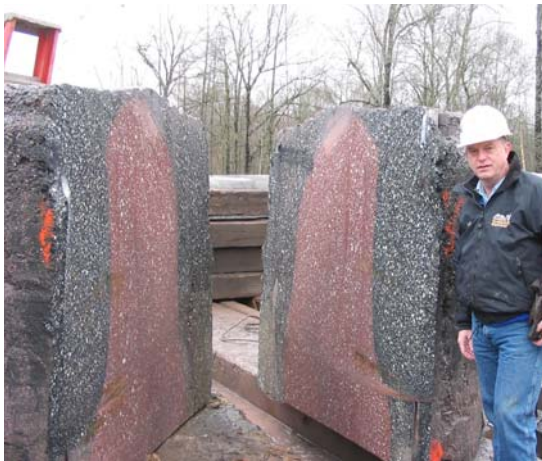
**Figure 8 Section of SC Coastal Mix, 6 ft from Base**

**Figure 9 Section of SCC Mix, 6 ft from Base**

**Figure 10 SC Coastal Mix, View Through Bottom 6 ft. (top of photo is bottom of shaft)**

- 2) The more fluid SCC mix resulted in flow very much closer to the tremie as indicated by the differences in diameter of the red concrete in Figures 8, 9, and 10. The upward flow of concrete from the discharge point on the tremie is apparently confined to a central portion of the shaft. Some mixing of new fresh concrete with older and previously placed concrete appears to occur, as evidenced by the patterns in Figure 11 and the concentric rings of colored concrete present in both shafts.

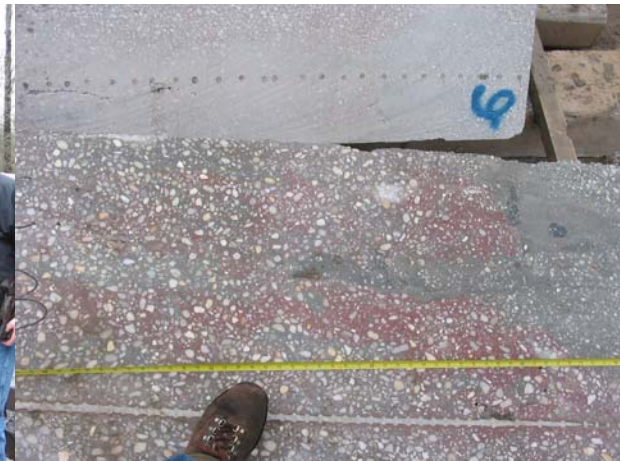
**Figure 11 SCC Mix, View of Mixing in Upper 13 ft.**
