Test Pile Program  
for  
US 90 Biloxi Bay Bridge  
Biloxi to Ocean Springs  
Mississippi

2006 STGEC  
November 1, 2006

W. Robert Thompson, III, P.E.  
Dan Brown and Associates, LLC

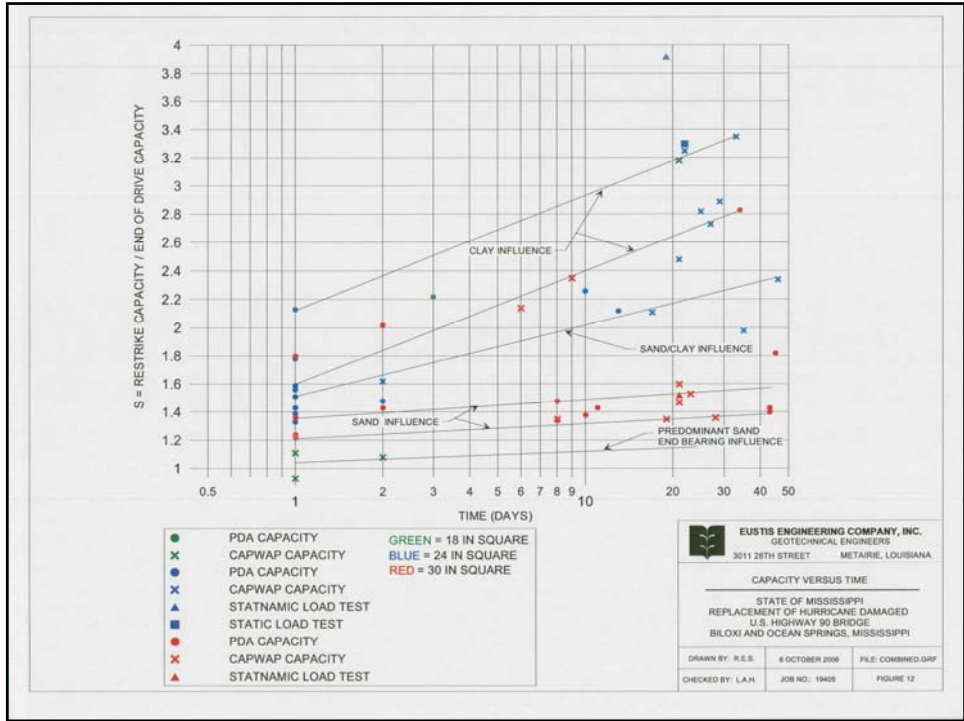
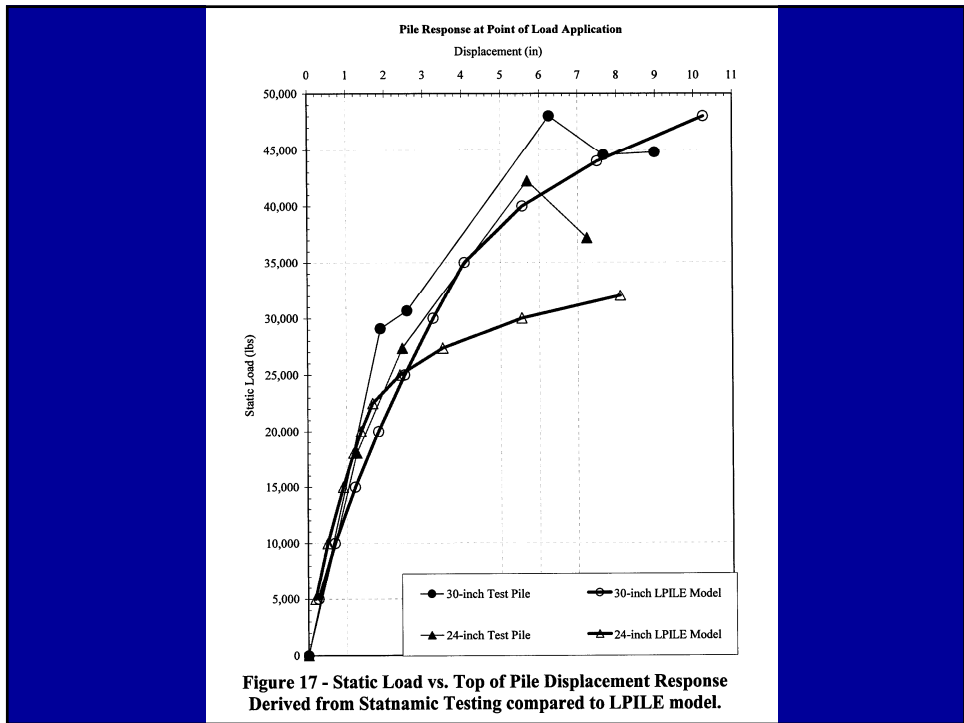
FIGURE 4, PAGE 1 OF 2

DYNAMIC PILE TESTING SUMMARY

PILE NUMBER	PILE TIP ELEVATION	PREDOMINANT SOIL INFLUENCE	BLOW COUNT AT TIP	HAMMER ENERGY AT TIP FT-KIPS	END OF DRIVE CAPACITY KIPS	RESTRIKE CAPACITY IN KIPS			
IP-11	-95	Sand	17@2"	66.5	1,243	1300 <sup>1</sup> 1.05 <sup>2</sup> 1 Day	1676 <sup>3</sup> 1.35 8 Days		
IP-12	-96	Clay	181	40	708	1278 1.8 <sup>2</sup> 1 Day	1516 <sup>3</sup> 2.14 <sup>2</sup> 6 Days		
IP-13	-93	Sand	145	73.8	1076	1480 1.36 <sup>2</sup> 1 Day	1486 1.34 <sup>2</sup> 10 Days	1584 <sup>3</sup> 1.47 <sup>2</sup> 21 Days	1957 1.82 <sup>2</sup> 45 Days
IP-14 (LST)	-93	Sand	74@3"	59.4	1109	1378 1.24 <sup>2</sup> 1 Day	1454 1.34 <sup>2</sup> 8 Days	1509 <sup>3</sup> 1.36 <sup>2</sup> 28 Days	1581 1.43 <sup>2</sup> 43 Days
IP-14 (AST)	-91	Sand	90@6"	47.1	1035			1575 <sup>4</sup> 1.52 <sup>2</sup> 21 Days	
IP-15	-90	Sand	36	69	1055	1503 1.43 <sup>2</sup> 2 Days	1557 1.48 <sup>2</sup> 8 Days	1423 <sup>3</sup> 1.35 <sup>2</sup> 19 Days	1450 1.40 <sup>2</sup> 43 Days

IP-16	-91	Clay	21@4"	33.3	613	1239 2.02 <sup>2</sup> 2 Days	1442 <sup>3</sup> 2.35 <sup>2</sup> 9 Days	1733 2.63 <sup>2</sup> 34 Days

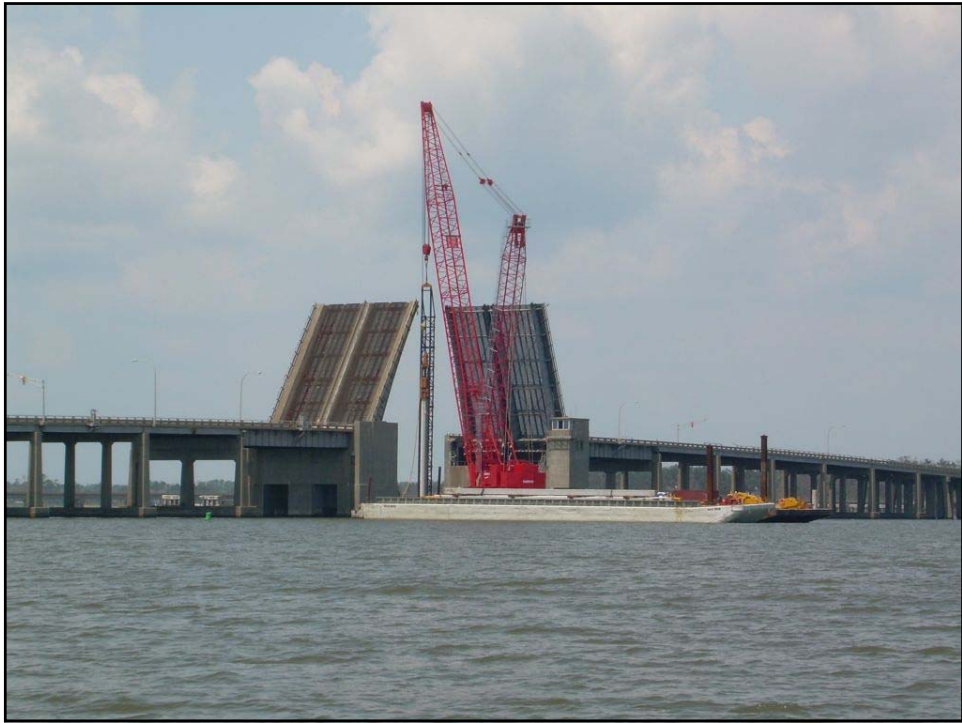
## Summary of Axial Load Test Data

Pile	Tip Elevation (feet)	Soil at tip	Maximum Load (kips)	Failure Load (kips)	Maximum Displacement (in)	Permanent Displacement (in)	Unit Side Friction (ksf)	Unit End Bearing (ksf)
IP-03	-95	Clay	697.5	697.5	2	1.5	1.2 - 2.4	13.4
IP-08	-99	Clay	1434	1390	1.15	0.35	0.7 - 2.5	44
IP-14	-91	Sand	1575	N/A	1.36	0.24	1.3 - 4.0	79.3

IP-03 – Static Test; IP-08 and IP-14 Statnamic Test
