# Soil Inclusions in Jet Grout Columns

**Timothy D. Stark**, University of Illinois; [tstark@uiuc.edu](mailto:tstark@uiuc.edu), **Paul J. Axtell**, Dan Brown and Associates, PLLC, **Justin R. Lewis**, Hayward Baker Inc., **John C. Dillon**, US Army Corps of Engineers, **William B. Empson**, US Army Corps of Engineers, **Joseph E. Topi**, US Army Corps of Engineers, **Francke C. Walberg**, URS Corporation

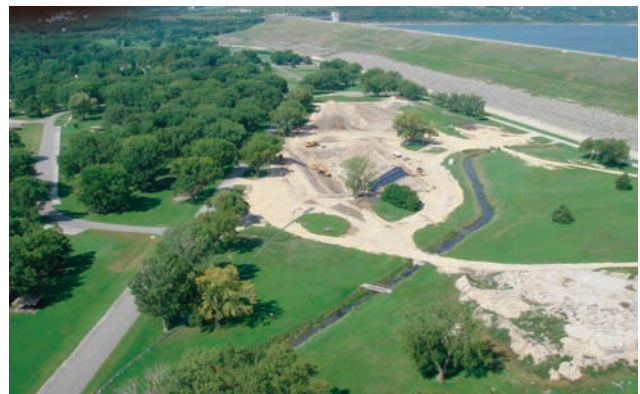
[FIG. 1] (a) Aerial view of Tuttle Creek Dam and downstream test site

Tuttle Creek Dam is a U.S. Army Corps of Engineers (USACE), Kansas City District (District) project located on the Big Blue River near Manhattan, Kansas, 125 miles (200 km) west of Kansas City. Fig. 1(a) is an aerial photograph of Tuttle Creek Dam and the test section located downstream of the dam. The dam is located 9 miles (14.5 km) upstream of the confluence of the Big Blue and Kansas rivers. Tuttle Creek Dam is 137 ft (41.8 m) high earth and rockfill embankment with a length of about 7500 ft (2300 m). It is constructed on 40 to 80 ft (12 to 24 m) of Pleistocene and recent alluvial sediments consisting of a natural fine grained blanket from 8 to 27 ft (2.4 to 5.2 m) thick underlain by 25 to 60 ft (7.6 to 18.3 m) of fine to coarse sands with some gravelly sands at depth.

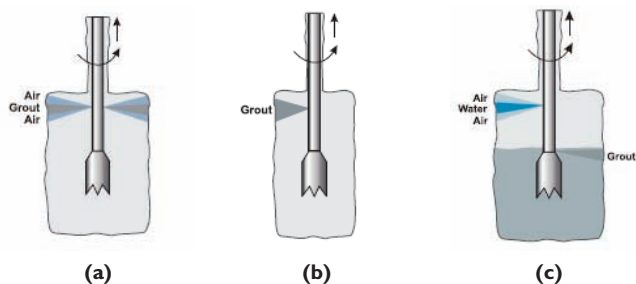
subsurface conditions. The three main jet grouting systems are single fluid, double fluid and triple fluid. In the single fluid system, Fig. 2(a), grout is also used as the cutting fluid and the cementing agent. Grout is pumped through the drillrod and exits the horizontal nozzle(s) in the monitor at high velocity [approximately 650 ft/sec (200m/sec)]. This energy breaks down the soil matrix and replaces it with a mixture of grout slurry and in situ soil (soilcrete). Single fluid jet grouting is most effective in cohesionless soils because only one fluid is being used in this method. However, all three jet grouting techniques are most effective in cohesionless soils. The double fluid system, Fig. 2(b), uses air and grout ejected from two different nozzles that are placed opposite each other on the rod. The air stream surrounds the grout stream to facilitate erosion. However, some double fluid systems do not use two nozzles. In the triple fluid system, Fig. 2(c), air and water are used as cutting fluids above the grout nozzle. The systems vary from contractor to contractor and are usually proprietary to each one. However, extremely high air, water, and/or grout pressure are required to create large diameter columns.

**[FIG. 2] Diagram illustrating jet grouting systems; (a) single fluid, (b) double fluid, (c) triple fluid (after www.haywardbaker.com)**

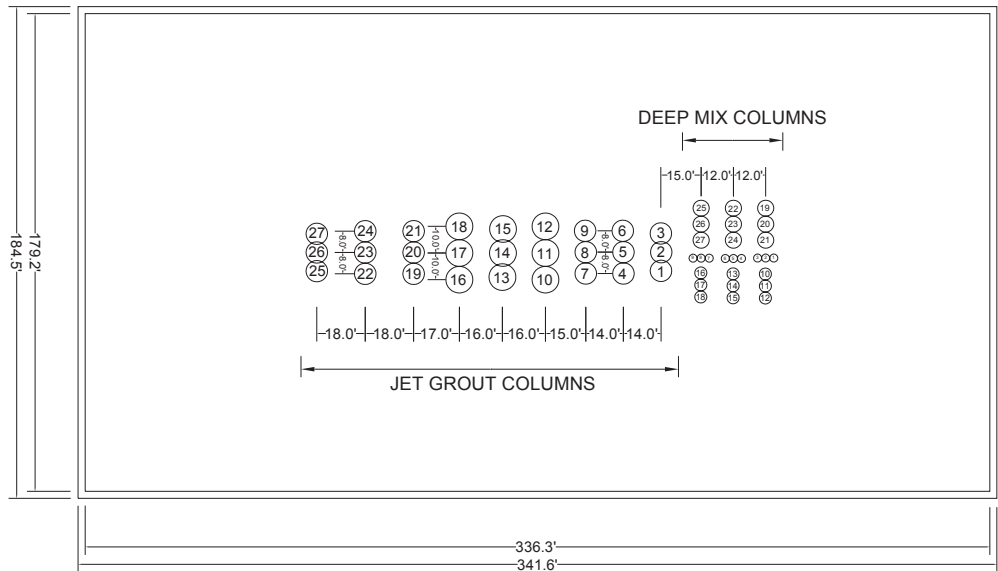
In 2006 the USACE awarded an option in the contract to conduct a test program downstream of Tuttle Creek Dam. The purpose of the test program was to investigate the viability of using jet grout and the deep mixing method (jet assisted soil mixing) columns for an upstream cutoff barrier (jet grouting only) and seismic stabilization retrofit. The test program site is located about 500 feet (150 m) downstream of the dam which is the light colored area in Fig. 1(a). Fig. 3 presents the layout of the test area with the soil mix columns on the right side of the area and the jet grout columns on the left side. The jet grout columns are labeled 1-27 on the left

and the soil mix columns are clustered on the right. The test area is approximately 185 feet (56 m) wide and 340 feet (105 m) long. The jet grout and soil mix columns are surrounded by a perimeter cement-bentonite cutoff wall constructed to bedrock which allowed the test section area to be dewatered so the columns could be exposed after curing.

[FIG. 3] Layout of downstream test site.

The jet grouting test program consists of twenty-seven jet grout columns in three groups of nine (see Fig. 3). The target diameters for these columns are from 8 to 10 ft (2.4 to 3.0 m). Columns were installed using both double and triple fluid jet grouting system. The double fluid jet grout system was used to create columns 19 through 27 with a target diameter of 8 ft (2.4 m). The triple fluid jet grout system was used to create columns 1 to 18 with a target diameters of 8 ft (2.4 m) for columns 1 through 9 and 10 ft (3.0 m) for columns 10 through 18. In each group of double fluid and triple fluid columns, one set of three columns was overlapped to assess column overlap strength and integrity. For example, triple fluid columns 1, 2, and 3 (8 foot diameter) and 13, 14, and 15 (10 foot diameter) are the two groups of triple fluid columns that are overlapped. The double fluid columns 25, 26, and 27 (8 foot diameter) is

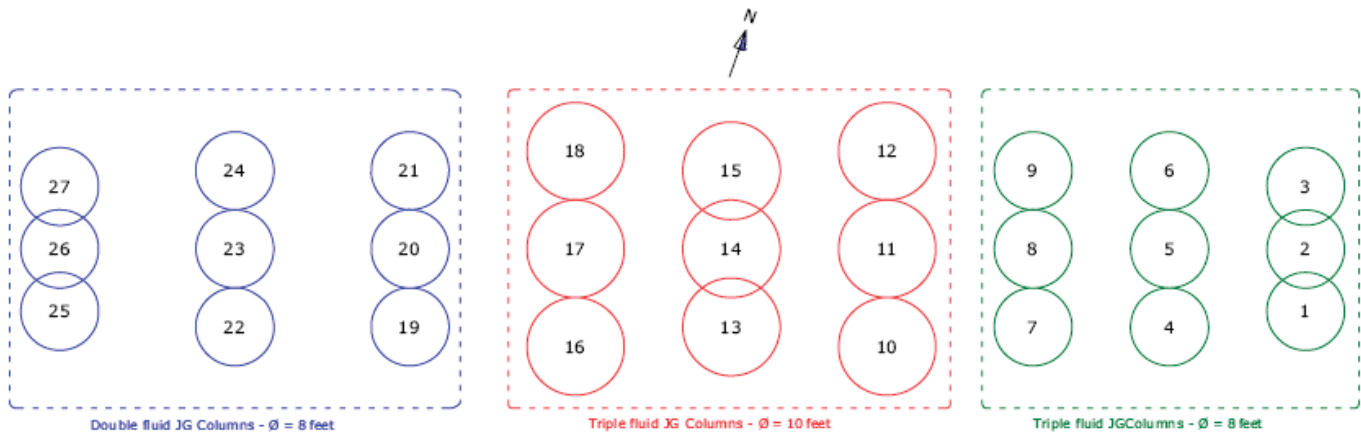
the group of double fluid columns that are overlapped. The water-to-cement ratio for the columns was varied from 0.75, 0.9, and 1.0. Fig. 4 shows the layout of the jet grout test columns. The columns were about 36 ft (11 m) in length with the top of the columns at about elevation 1016 feet (310 m) (10 feet or 3 m below ground surface) and the base at about elevation 980 feet (299 m).

[FIG. 4] Final layout of jet grout columns for Tuttle Creek Dam test program. (Treviicos, 2006)

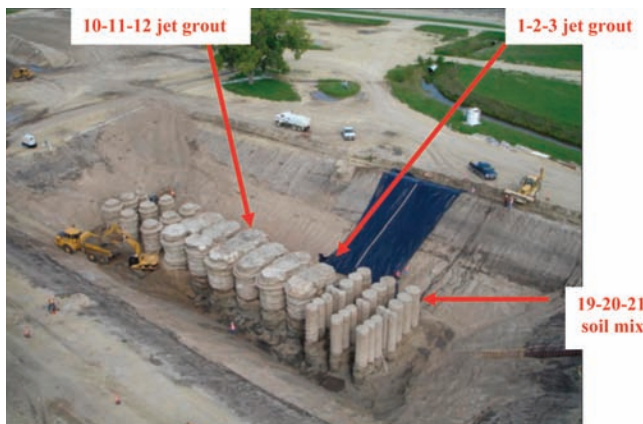
The columns were then cut along the line of the group, effectively cutting each column in half. The cutting was performed using a diamond wire saw. Fig. 5 also shows the excavated columns that were designated for sectioning including soil mix columns 19-20-21 on the left. Fig. 6 shows the three sets of columns that were sectioned with the two sets of jet grout columns in the foreground and the soil mix columns at the end. The column group closest in Fig. 6 is jet grout columns 10-11-12 (nominal 10 ft or 3 m diameter), middle column group is 1-2-3 (nominal 8 ft or 2.4 m diameter); and back group is 19-20-21 of the soil mixed columns (6 ft or 1.8 m) diameter.

[FIG. 5] Jet grout and soil mix columns during excavation and columns to be sectioned.

Table 2 presents the jet grouting parameters to construct the two clusters of columns that were sectioned. These two clusters are shown in Fig. 5 and are 1, 2, and 3 and 10, 11, and 12. In Table 2, C/W defines the cement to water ratio and B/W defines the bentonite to water ratio.

In addition to sampling the inclusions in the jet grout columns, the soils in the sides of the excavation, see Fig. 5, were sampled to compare with the inclusion soils to aid in assessing the origin of the inclusions. Grab samples were taken along the north slope of the excavation (side with black sheeting on the slope, closest to the dam in Fig. 5). Two (2) locations were sampled, along the alignment of columns 1-2-3 and 10-11-12. Six (6) samples (TP-1 1/2/3 through TP-6 1/2/3) from column line 1-2-3 were taken at depths of 2.5 ft, 7.5 ft, 12.5 ft, 17.5 ft, 22.5 ft, and 27.5 ft. Eight (8) samples (TP-1 10/11/12 through TP-8 10/11/12) from

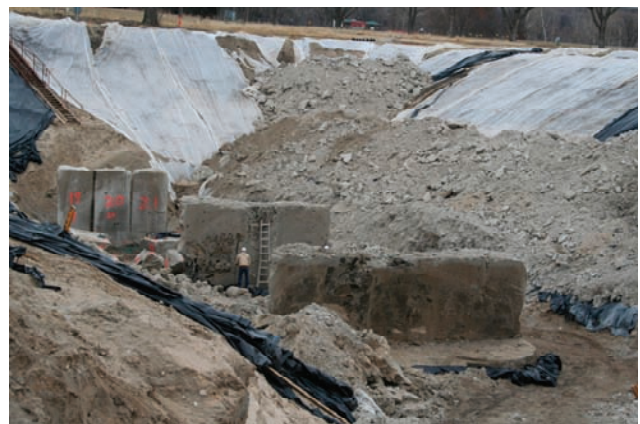
[FIG. 6] Sectioned double and triple fluid jet grout and soil mix column using a diamond wire saw.

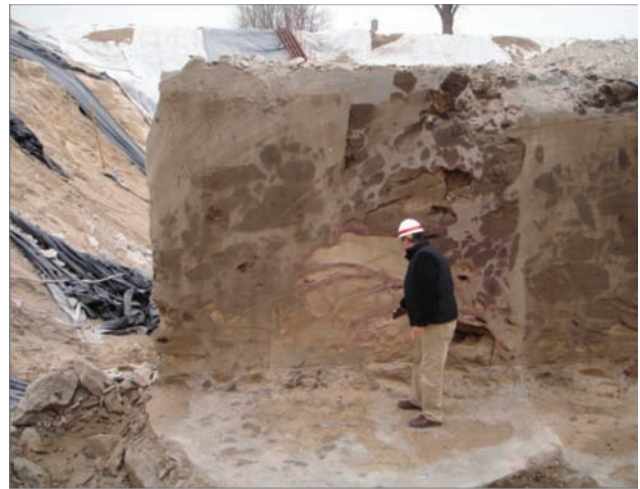
Exposure of the interior of the jet grout columns revealed soil inclusions of considerable number and size. For example, Fig. 7 shows about 50 to 60% of the interior of the columns is soil. The darker colored inclusions are cohesive soil and the light colored areas, directly in front of the person in the photograph is intact untreated sand. The presence of both sand and clay inclusions in the columns was unexpected based on the results of the core drilling and external appearance of the excavated columns. In addition the amount and size of the inclusions found during the sectioning was surprising. Thus, coring after curing of the soilcrete may not provide a representative view of the amount of soil inclusion in the completed column. In contrast, the soil mix column group of 19-20-21 had few inclusions, and those that it did contain were small and not deemed detrimental to the column integrity. The soil mix columns were essentially homogeneous soilcrete. Double fluid system jet grout columns were not sectioned.

[FIG. 7] Close up of sectioned triple fluid jet grout columns 10-11-12 (10 ft diameter)

little to no cementation (see Figs. 7, 12, and 13). In some of the inclusions the intact natural bedding is still present. All of the sand inclusions (JG 10-5, JG 11-4, JG 12-5, and JG 12-6 in Fig. 14) have grain size distributions that are comparable with native soil sample TP-5 (10/11/12). The TP-5 (10/11/12) sample was obtained from a depth of 20.5 ft (6.2 m); however, the JG 10-5 inclusion shown in Fig. 10 is clearly at a depth of almost 35 ft (10.7 m). This suggests that the sand blocks became detached at a depth of about 20.5 feet and sunk through the slurry and grout to a depth of almost 35 feet (10.7 m). These large chunks could have detached from the roof or sides of the excavation. The sand blocks are still intact because they detached after the jet had moved above a depth of 20.5 feet (6.2 m) and/or the blocks are large enough that the jet could not break up the entire block. Figs. 7, 12, and 13 show

the large sand inclusions are intact and the sand shows little or no cohesive material. The sand may have a small amount of cementation but the SPT N-values of 4 - 24 suggest the level of cementation is small.

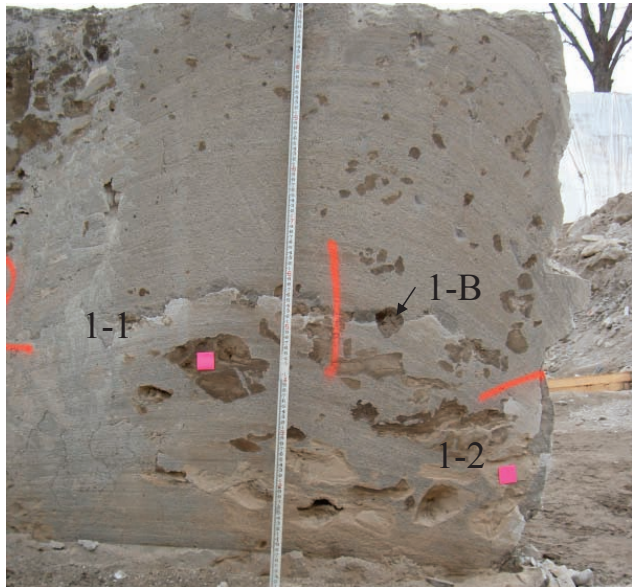
In columns 1 (Fig. 8) and 3 (Fig. 9), the inclusions decrease in the top portions because the eroded soil can be removed as a result of

its proximity to the extraction point. However, the inclusions increase with depth because of the presence of the grout and the long distance to the extraction point as shown in the photographs. Thus, sampling of the completed columns should focus on the bottom of the columns to investigate inclusions.

[FIG. 8] Soil inclusions in triple fluid jet grout column #1.

10 (10-1, 10-2, 10-3, 10-4, and 10-5). Figs. 8 through 12 show the location of these grab samples and the inclusions that were sampled.

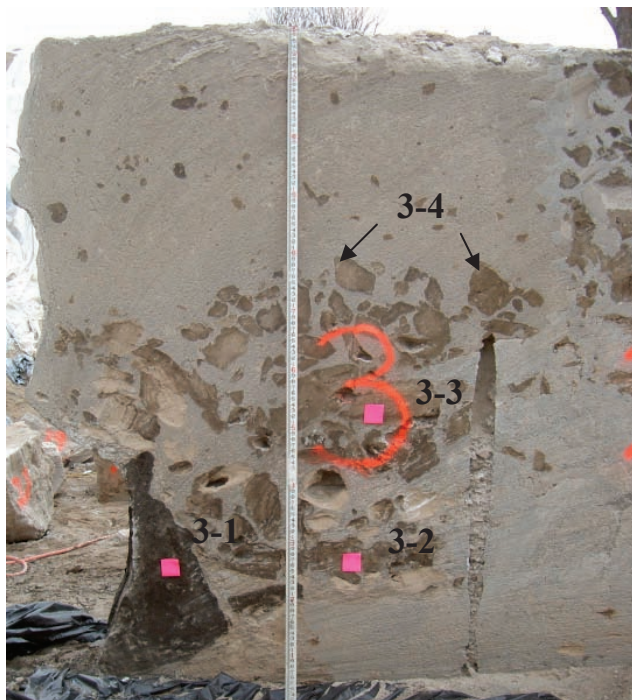
1-2-3 and 10-11-12 range from clay and silt to entire pockets of sand. Column 3 shown in Fig. 9 shows a large clay inclusion at the lower left corner of the cut face. Fig. 13 presents a close-up of some of the sand inclusions in column #12 as well as voids which apparently were formed by pockets of trapped injected air in the grout slurry prior to hardening. A close inspection of the sand in the inclusions revealed remnants of bedding in the sand that is naturally horizontal. This suggests that large pieces of sand were eroded or fell off the roof of the excavated chamber instead of the sand being eroded and broken up by the action of the air-water jet and then mixed with grout by the action of the grout jet.

[FIG. 9] Soil inclusions and vertical hole from post-construction coring in triple fluid jet grout column #3.

The clay and silt samples from both the inclusions and native soils show a range of Atterberg limits and clay size fractions. Fig. 15 shows the sample elevation and index properties of the clay samples along column line 1-2-3 while Fig. 16 shows the index properties along column line 10-11-12. The clay size fractions are indicated by the triangular symbol. Some interesting trends can be discerned from this data. For example, the soil inclusion JG3-1 (Fig. 9)

shows nearly identical Atterberg limits as the insitu soil at a depth of 7.5 feet (2.3 m) (elevation 1017.5 ft or 310 m) (TP-2 7.5 ft 1/2/3). Thus, the inclusion at JG 3-1 (at about elevation 990 to 993 ft or 301.8 to 302.7 m) is probably derived from similar material near the top of the column (at about elevation 1015 or 309.4 m). A similar conclusion might be drawn for soil inclusions JG 10-1 (at about elevation 997 ft or 303.9 m) and 10-2 (at about elevation 996 ft or 303.6 m) showing similar Atterberg limits as the insitu soil at a depth of 17.5 feet (5.3 m) (about elevation 1007.5 ft or 307.1 m) (TP-4 17.5 ft 10/11/12).

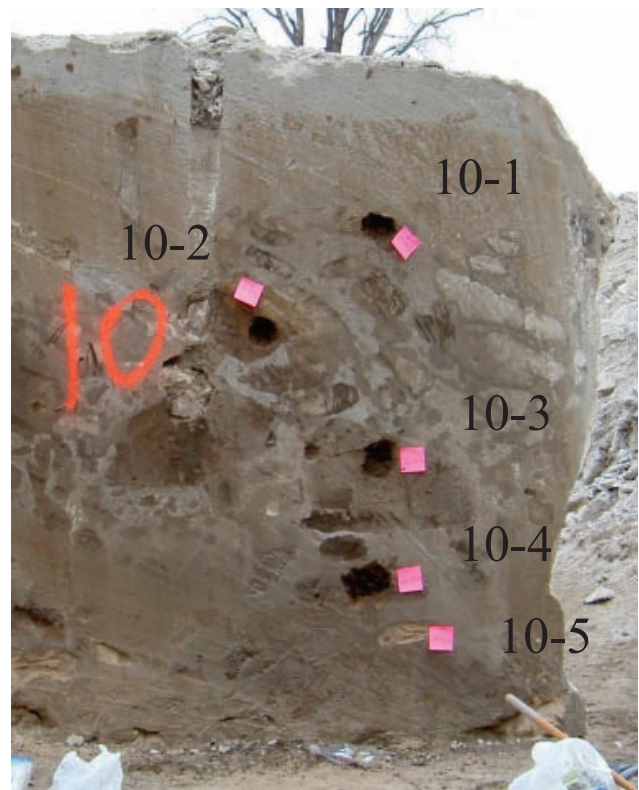
[FIG. 10] Soil inclusions in triple fluid jet grout column #10.

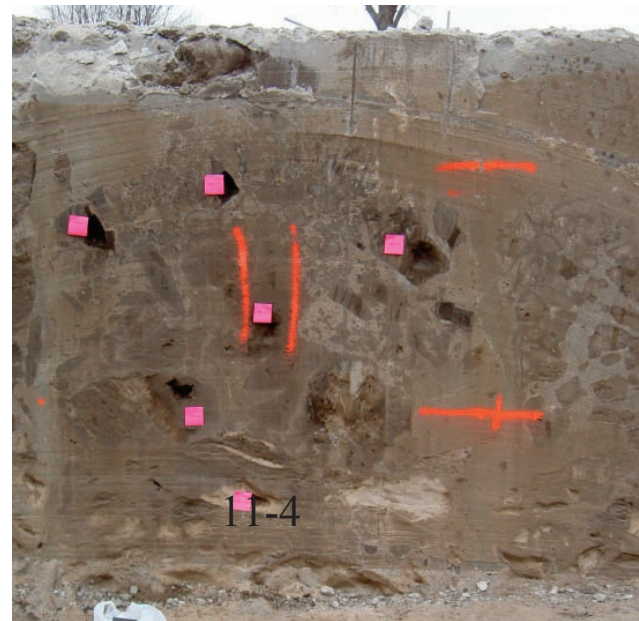
[FIG. 11] Soil inclusions in triple fluid jet grout column #11.

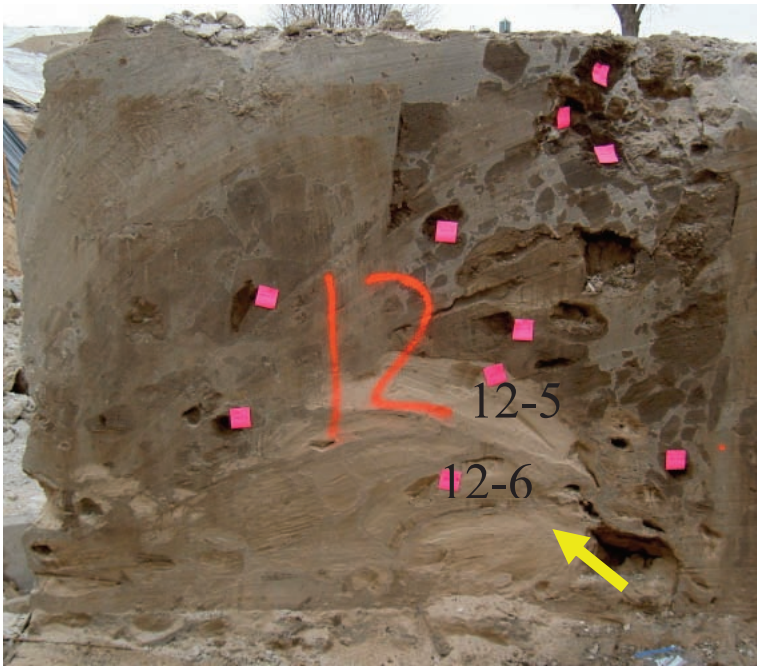
[FIG. 12] Soil inclusions in triple fluid jet grout column #12.

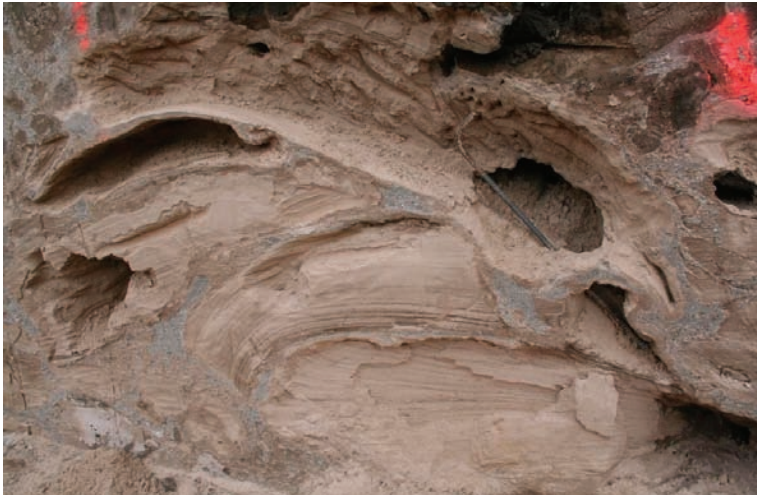
[FIG. 13] Close-up of sand inclusions in triple fluid jet grout column #12, see arrow in Fig. 12.

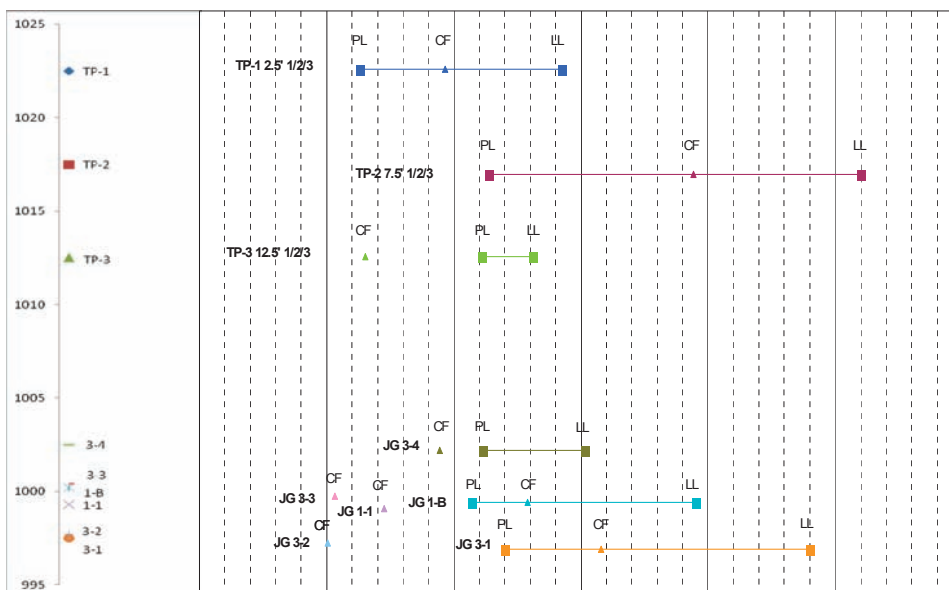
[FIG. 15] Sample elevation, test pit/sample number, Atterberg limits and clay size fraction for samples from triple fluid jet grout column line 1-2-3.

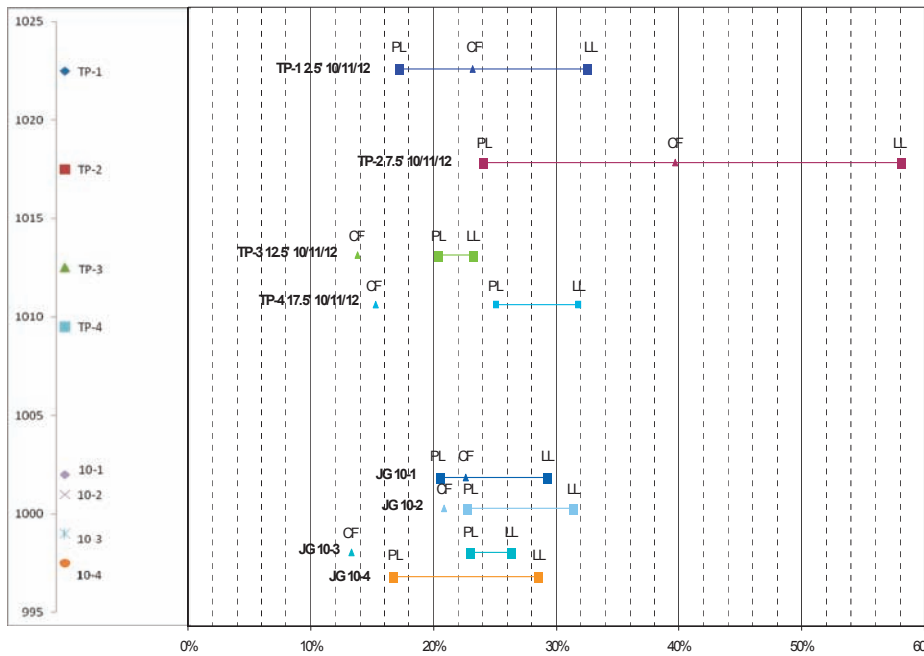
[FIG. 16] Sample elevation, test pit/sample number, Atterberg limits, and clay size fraction for samples along triple fluid jet grout column line 10-11-12.

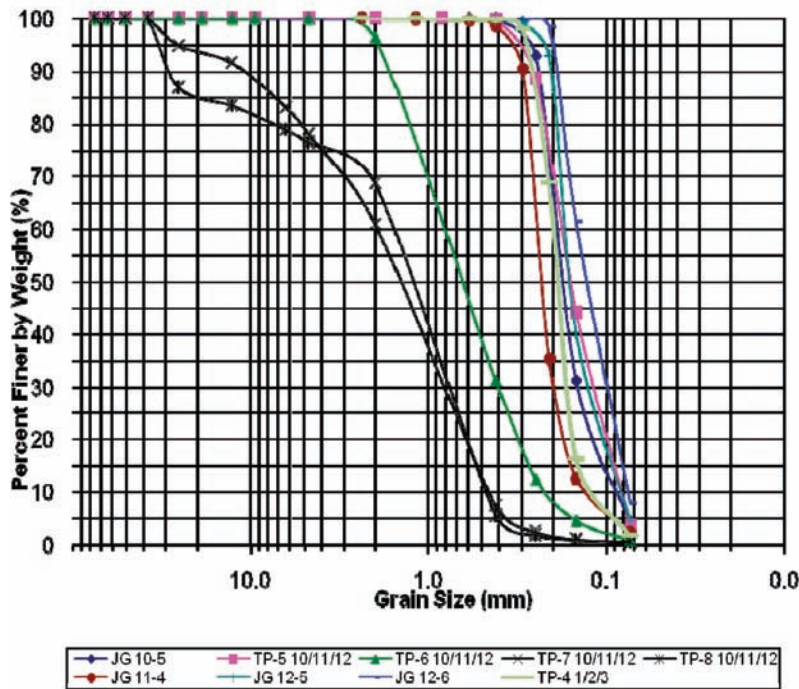
The sand samples were compared based on their grain size distributions instead of Atterberg limits. Five samples were tested in the laboratory in Urbana, Illinois: JG 10-5, TP-5 (10/11/12), TP-6 (10/11/12), TP-7 (10/11/12), and TP-8 (10/11/12). Additionally, three (3) grain size distributions were performed by USACE on samples JG 11-4, JG 12-5, and JG 12-6 at the field laboratory. The various grain size distributions are shown in Fig. 17.

The grain size distributions of the four soil inclusion samples (JG 10-5, JG 11-4, JG 12-5, and JG 12-6) compare favorably with the distribution for TP-5 (10/11/12). This is also evident by comparing the D50 values for samples JG 10-5, JG 11-4, JG 12-5, and JG 12-6 with the D50 value for TP-5 (10/11/12) in Table 3. The values of D50, grain diameter at 50% passing, for samples JG 10-5, JG 11-4, JG 12-5, and JG 12-6 range from 0.14 to 0.23 mm which is a narrow range. The values of D50 for sample TP-5 (10/11/12) is 0.17

[FIG. 17] Grain size distributions for sandy samples of soil inclusions in triple fluid columns 10, 11, and 12 and native soil.

mm which is in excellent agreement with the soil inclusion D50 values. The D50 value for TP-4 (1/2/3) is also in agreement at 0.19 mm but is not used in this comparison because the sample was taken near the soil mix columns at the other end of the test area. However, the agreement between the values of D50 for TP-4 (1/2/3) and TP-5 (10/11/12) also confirms the uniformity of the shallow sand.

1007.5 to 995 feet, (307.1 to 303.3 m, see Fig. 14) which have a finer gradation than the deeper sands which are coarser. Thus, the soil inclusion samples JG 10-5, JG 11-4, JG 12-5, and JG 12-6 appear to consist of the fine sand from elevation 1007.5 to 995 feet (307.1 to 303.3 m) - see Fig. 14. This means the fine sand inclusions in JG 10-5, JG 11-4, JG 12-5, and JG 12-6 are below the natural depth of the fine sand in the excavation walls (see Fig. 14). However, this depth of these soil inclusions is still higher than the coarse sand (elevation 995 to 965 feet (303.3 m to 294.1 m) - see Fig. 14). Thus, it appears that the fine sand inclusion fell or sank through the fluid grout before it set.
