Performance of Drilled Shaft Foundations in Limestone, Nashville, Tennessee

by Dan Brown, P.E., Ph.D.
and Robert Thompson, P.E.

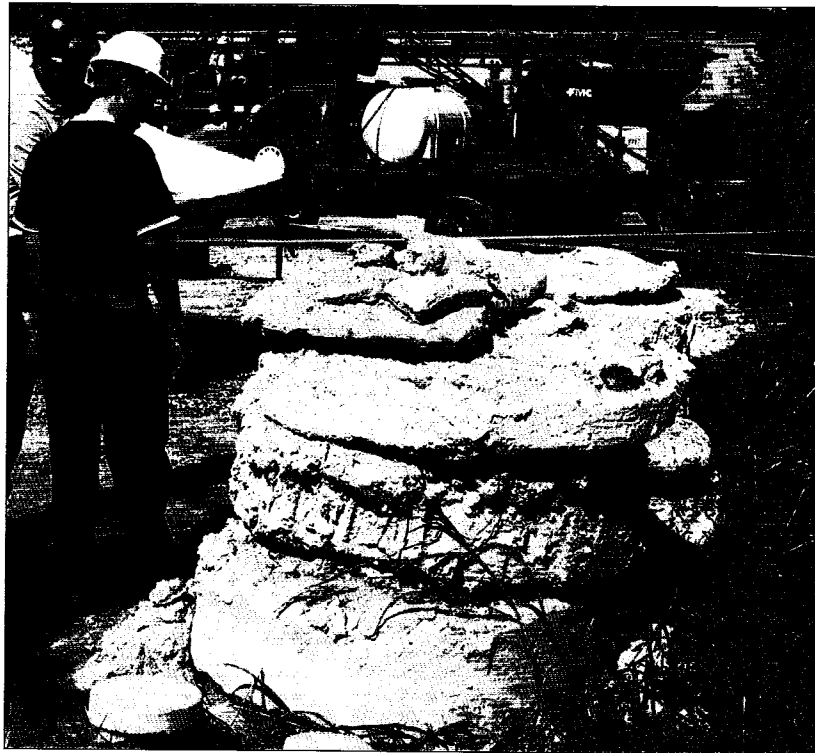
Figure 1 Rock from Coring Tool Used to Excavate Socket for Test Shaft 1.

After making borings to evaluate several possible test sites, a site was selected with the desired qualities, i.e., rock that was on the lower bound of typical Nashville conditions. The site was located at the equipment yard of Long Foundations* in Hermitage, Tennessee on the east side of Nashville. According to USGS geologic maps, this site is underlain by Carters Limestone of the Stones River Group, a fine-grained, yellowish-brown limestone with thin beds of bentonite clay. This formation is typical of the Central Basin limestones in the Nashville area. A photo of the rock from the coring tool used to excavate the rock socket of Test Shaft 1 is provided in Figure 1.

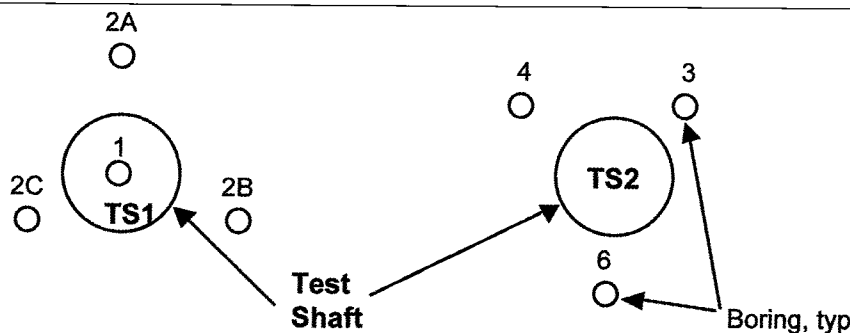
Figure 2 Test Shaft and Boring Layout (no scale).

Soil borings were drilled in the area of the two test shaft locations as illustrated in Figure 2. The two shafts were approximately 30 feet apart, with the borings approximately 8 ft from the center of the test shafts. The data from the borings suggest that the rock for 3 diameters below the base of Test Shaft 2 (TS2) was somewhat more sound with average percent recovery
