**CASE HISTORIES OF MICROPILE IN KARST:  
THE INFLUENCE OF INSTALLATION ON DESIGN AND PERFORMANCE**

Michael J. Bivens, P.E., Member, Geo-Institute<sup>1</sup>  
Timothy C. Siegel, P.E., Member, Geo-Institute<sup>2</sup>

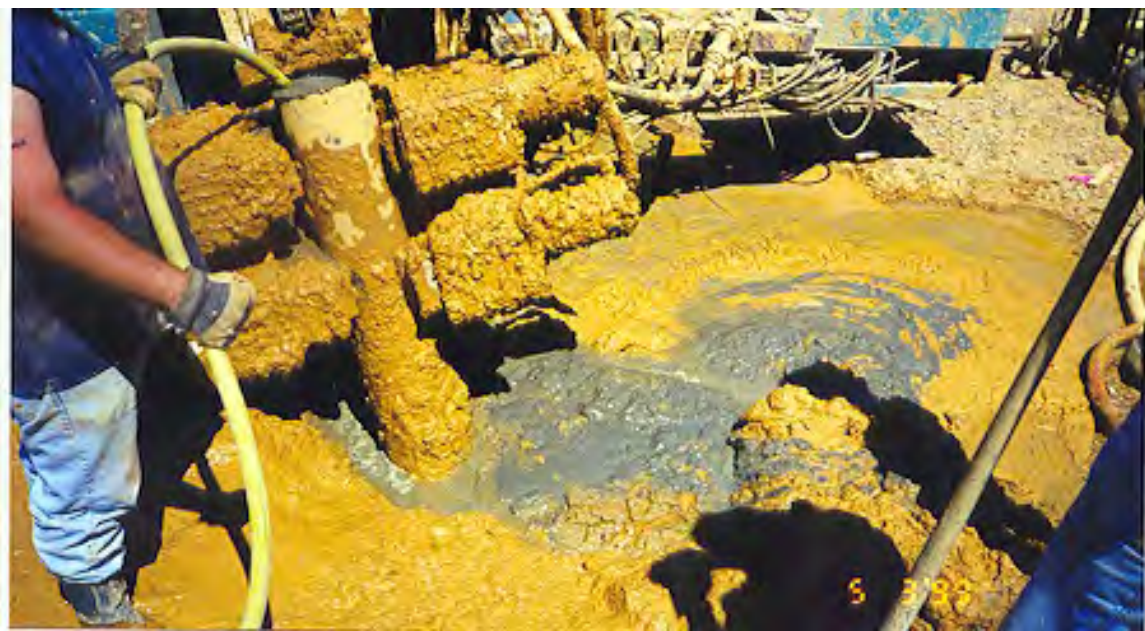
During installation of the micropiles, the ground surface and subsurface, were dramatically disturbed. It is believed that the water and air introduced during drilling promoted the soil softening and downward soil migration that is characteristic of karst. This latter conclusion is based on the localized subsidence observed around the micropiles. Figure 2 illustrates the consistency of the soils after disturbance. The localized subsidence and extremely soft soils led the design team to be concerned that the actual lateral resistance would be lower than it was represented in the design analysis. To restore lateral support to the micropiles, cap/compaction grouting was performed in the area to: (1) place low mobility grout at the rock surface to create a physical barrier to the downward migration of the overburden clay soil, and (2) place low mobility grout at incremental depths to fill voids, displace very soft soils, and reinforce the overall soil profile.

**Figure 2. Disturbed Soil after Micropile Installation**

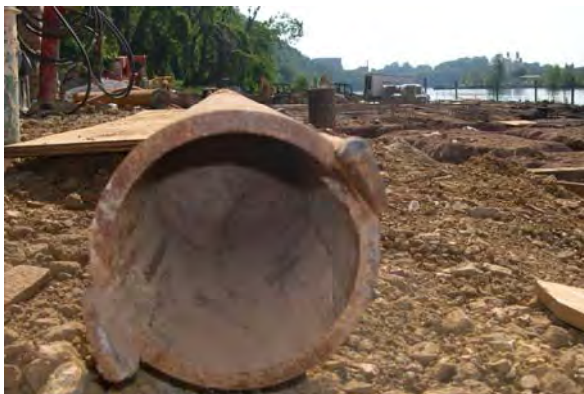
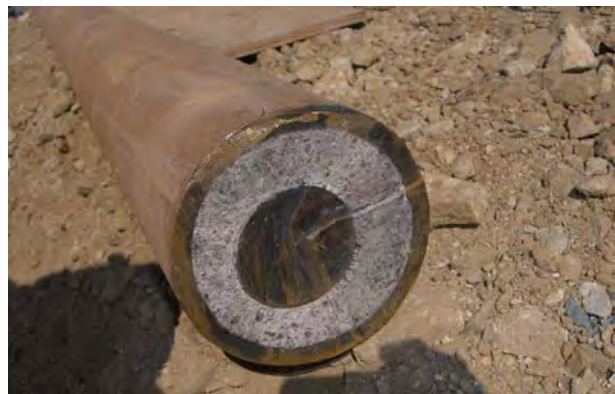
During excavation of a pile cap prior to cutting off the micropiles, the pile tops appeared to be moved by the excavation equipment. Upon closer inspection, it was discovered that the piles were easily lifted by the excavator bucket and had obviously failed under the minor tension loading placed on the pile by the excavator. Additional field observations indicated that other piles exhibited the same behavior in uplift. The problems were communicated to the pile system's design engineer and a comprehensive testing program was implemented to determine the extent of the problem. It was concluded that the central reinforcing bar that was designed to connect the bond zone of the pile to the upper cased zone failed to extend to the bottom of the drilled hole. Figures 4a and 4b are photographs taken of one of the faulty micropiles where the central bar did not get placed low enough in the pile. Figure 4a shows a pile that was pulled from the ground with no reinforcing bar extending past the casing bottom. Figure 4b illustrates that the central reinforcing bar had not fallen through the grout to the bottom of the drilled hole as designed; rather it was located at a higher elevation, completely inside the structural casing. This problem was found on several of the piles and was attributed to a thick grout mixture, battered piles, and poor quality control procedures.

**Figures 4a and 4b: Photographs of Faulty Micropiles following Extraction**

In order to identify the affected piles, a tension load was applied to all of the installed piles. Each of the affected piles was extracted and new piles were installed. Investigation of the extracted piles led to the conclusion that a combination of thick grout, tight-fitting centralizers, and steep batter angles all worked in combination to create the problem. Each of these problems could be traced back to a decision to alter the normal micropile installation procedures used by the specialty contractor to suit the site-specific project requirements. Nevertheless, it became apparent that no significant documentation efforts were made during pile installation to check that critical stages of the construction process were completed successfully on each pile.
