Design and Construction Challenges at the kcICON Bridge

The Christopher Bond Bridge is a cable-stayed structure that will span the Missouri River and create a new gateway into Kansas City, replacing the existing Paseo Bridge. Also known as kcICON, the name of a larger area project, the bridge will open in 2011. The bridge has 7 spans totaling 1,715 ft, with a 550 ft main span and a 452 ft back span. The main pylon foundation is in the river, near the navigation channel, and subjected to significant vessel impact forces. This layout was efficient because the robust main pylon support could be readily proportioned to resist lateral forces from barge impact, and the more lightly-loaded approach pier foundations could be located away from potential vessel collision. The trade-off was the fact that marine construction was required for the largest foundation unit. The approach piers utilized individual drilled shafts under each column.

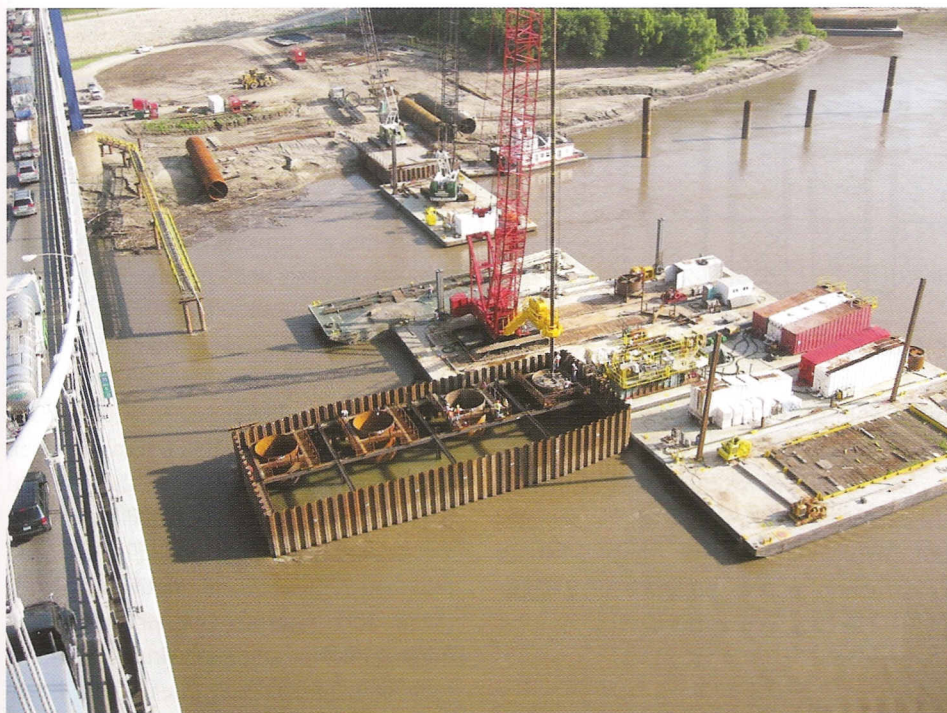
The main pylon foundation consists of a single footing, approximately 116 ft by 48 ft in plan, supported by a group of 8 drilled shafts (Figure 1). The drilled shafts are constructed with a permanent steel casing extending into the top of the shale bedrock, with a 10.5-ft-diameter socket extending into the shale formation. Each shaft design provides a required axial resistance of approximately 10,000 kips.

Figure 1. Schematic diagram of main pylon foundation

This single, large pile cap with multiple shafts provides a robust and reliable foundation that is not sensitive to scour,

and that has strength that substantially exceeds potential vessel impact or lateral load demand. The permanent steel casings provide additional strength, ductility and confinement for the bending stresses in the drilled shafts and facilitated construction by providing a stable environment in which to construct the rock socket. The multiple shafts provide reliability as a redundant foundation system.

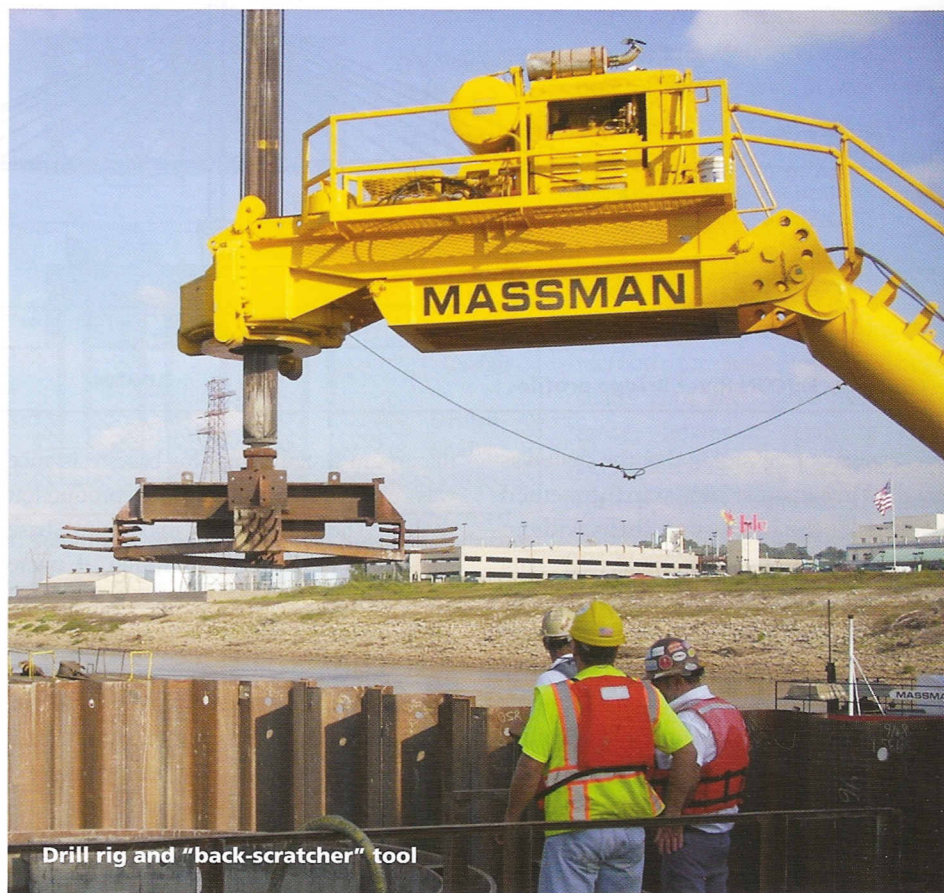
Drill rig and "back-scratcher" tool

The excavation tools used for the load test shaft replicated the methods used for the production shafts. These tools included digging buckets and augers to excavate the rock socket, followed by the use of a "back-scratcher" to scarify the sidewall of the rock socket prior to final clean-out with a hydraulic pump. Video inspection of the shaft base was conducted with a mini Shaft Inspection Device (mini-SID) for the load test shaft and the first two production shafts at the pylon. The contractor also used the mini-SID on the first two shafts at the approach piers to verify that the procedures achieved the desired level of base cleaning.
