DFI JOURNAL

Case History: Foundations for the New Mississippi River Bridge, St. Louis

ABSTRACT

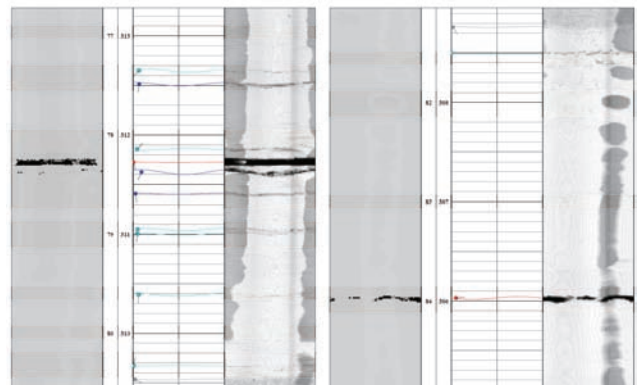
[FIG. 4] ATV Logs from Load Test Location

In addition to conventional coring, additional information was obtained from the boreholes using an Acoustic Televiewer (ATV) at each exploratory hole that was cored. A more detailed discussion of the results of the ATV, along with a description of the technology and its application, are provided by Keller (2010). Although the concern for solution cavities was a motivating factor for the use of the ATV investigation, the ATV proved to be beneficial to the construction operations. The constructor was able to utilize the ATV information to identify seams or horizontal fractures within the bedrock. The rock excavation within the

base of the test shaft should be a mirror image of the rock shown in Fig. 10. The investigative core hole is visible in the photograph. The two seams in the ATV logs of Fig. 4 at elevation 311.7 ft (95.0 m) and 306.0 ft (93.3 m) correspond to the top and bottom of core number 3 at the left in Fig. 8. The dark band in the center of this core is also evident in the ATV log shown in Fig. 4.

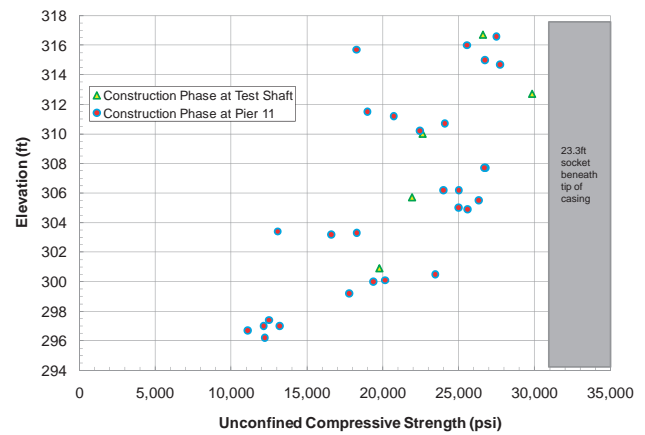
[FIG. 5] Bedrock Unconfined Compressive Strength at Test Shaft (1 psi = 6.9 kPa)

Unconfined compression tests on the rock cores at the test shaft location indicate that the strength of the rock was extremely high, and exceeded the compressive strength of the concrete. Five unconfined compression tests were performed on rock core recovered from the investigative boring at the location of the test shaft, as indicated on the boring log in Fig. 2 and shown graphically in Fig. 5. The average value of the five tests is 24,145 psi (166 MPa) and ranges from 19,767 psi (136 MPa) to 29,829 psi (206 MPa). Other test data from nearby Pier 11 are also shown, and these data suggest that the rock at the load test location had similar characteristics to the nearby pylon location. The data show a slight trend of decreasing strength with depth.

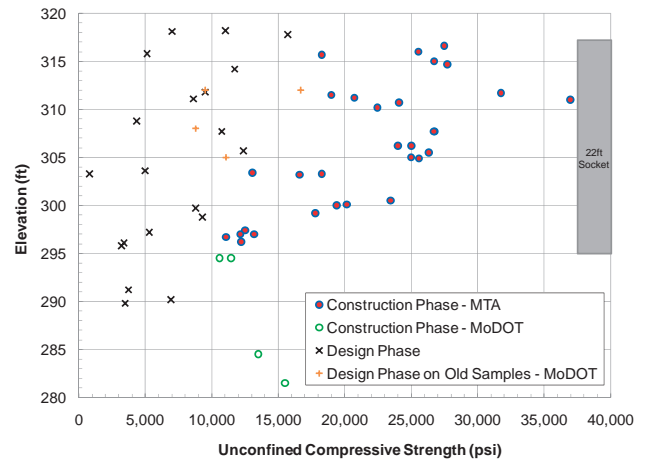
[FIG. 6a] Bedrock Unconfined Compressive Strength at Pier 11 (1 psi = 6.9 kPa)

An inconsistency was noted with respect to the measured unconfined compressive strengths; as evident on Fig. 6, the values reported from borings provided prior to bid (design phase) were significantly lower than those obtained during the post-award investigation (construction phase). The writers had no involvement in the design phase investigation and can only speculate that such a discrepancy may result from sampling technique, sample transportation, or test sample preparation.

A small portion of the construction-phase drilling operation and laboratory procedures were observed by the primary author. In all instances, recovered construction-phase core samples were tested within 24 hours of recovery. Upon discovering the apparent discrepancy between design- and construction-phase strengths, MoDOT independently tested some of the remaining construction-phase samples. These reported values, also shown in Fig. 6, do not appear to differ significantly from the construction-phase values reported by MTA, although they do exist at the lower range of the measured values. MoDOT also tested some of the remaining design-phase cores that had been in storage for approximately 1 year, the results of which are also shown in Fig. 6.

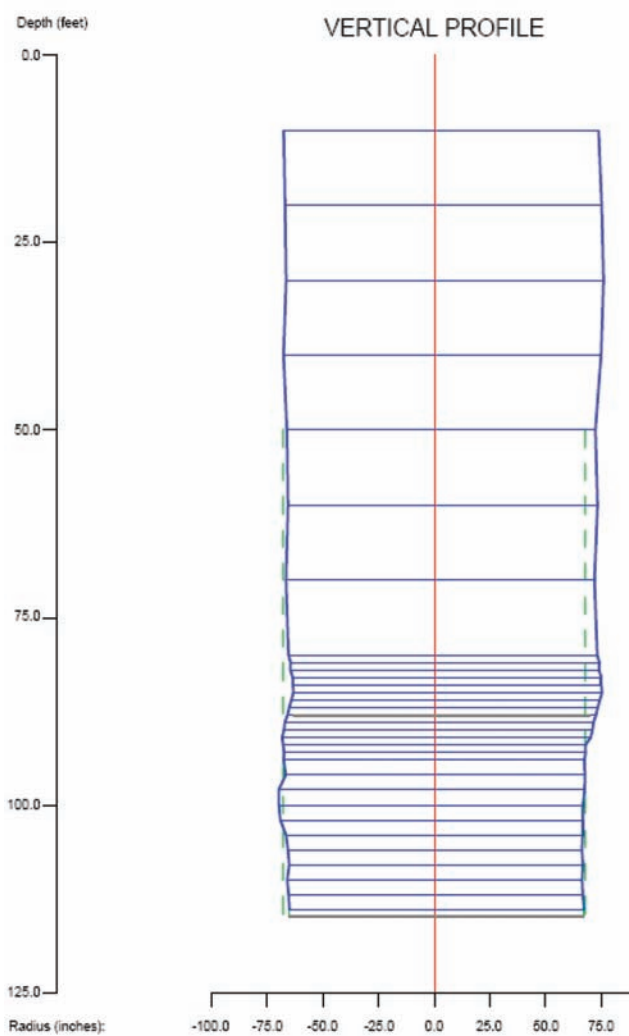
[FIG. 11] SoniCaliper Results in Test Shaft Excavation

The SoniCaliper test was performed on June 2, 2010, the results of which are provided in Fig. 11. The results generally indicate a slightly oversized diameter rock socket with an average diameter of about 11.5 ft (3.51 m). This value was determined by dividing the average of the 13 perimeter measurements reported by LoadTest in the rock socket by pi. Note that an 11.5-ft (3.51-m) diameter socket agrees fairly well with back-calculated values using the concrete placement (depth-volume) records discussed below. Of special interest, the shape of the permanent casing near the tip was as estimated by the SoniCaliper is not entirely circular. This phenomenon may be the result of some sort of false-positive signal received by the tool as a result of something outside of the casing. The observed shape could also be a result of the aforementioned barge impact or deformation incurred during installation when seating the casing into rock.

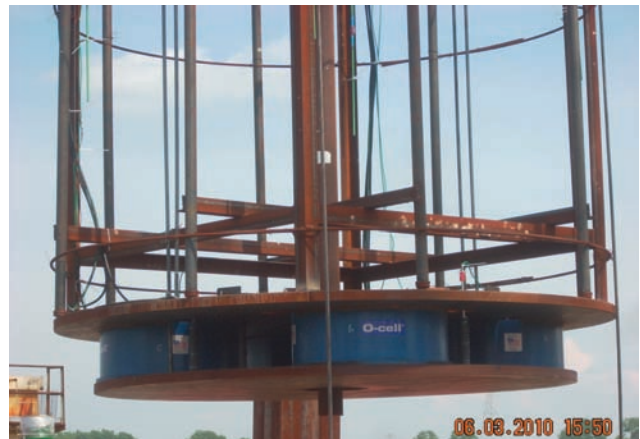
[FIG. 12] O-Cell Assembly

The O-cell assembly and frame were placed on June 3. A photograph of the frame and assembly is provided in Fig. 12. The O-cell assembly consisted of four 34-inch (864-mm) diameter O-cells with a rated bi-directional capacity of 6,000 tons (53.4 MN) each for a total of 24,000 tons (213.5 MN). The top plate is 2-inches (51-mm) thick and 10.5 ft (3.20 m) in diameter. The bottom plate is also 2-inches (51-mm) thick but only 9 ft (2.74 m) in diameter. The bottom of the bottom plate is

Three levels of four vibrating wire sister-bar strain gages, spaced at 90° are included above the top plate to estimate load shed in side resistance. Four displacement transducers and two tell tales are included to monitor movement of the plates and shaft.

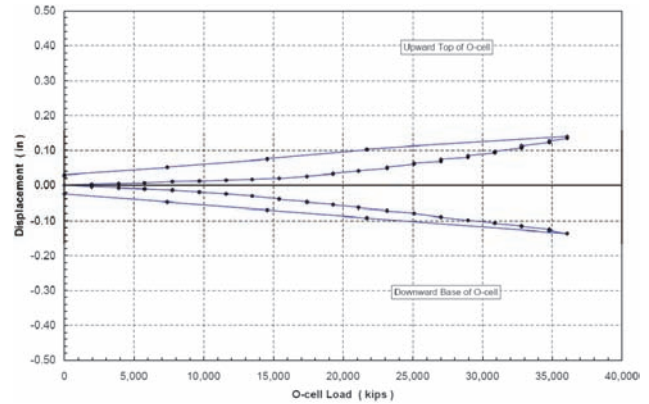
[FIG. 13] O-cell Load-Displacement (courtesy of Bill Ryan and LoadTest, Inc.)

The bi-directional static O-cell load test on a full-scale non-production test shaft was performed by LoadTest on June 9, 2010. A maximum bi-directional load of approximately 72,000 kips (320 MN) was applied to the shaft. The net load acting upward was 35,775 k (159 MN) and has been corrected for weight of concrete. The load acting downward was 36,067 k (160 MN). Under this load, and as shown in Fig. 13, the base of the shaft deflected downward about 0.14 inches (3.6 mm) below the O-cells and upward about the same distance above the O-cells.

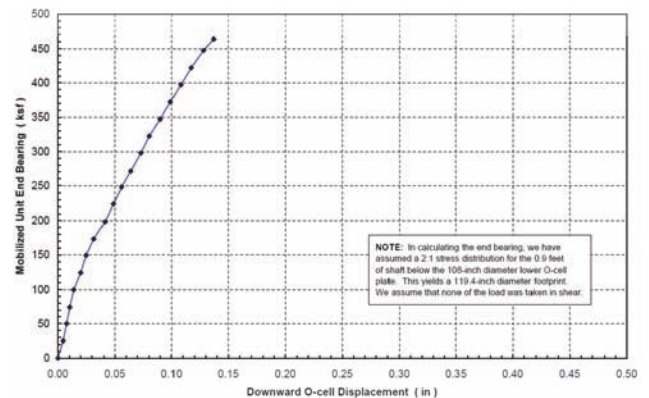
[FIG. 14] Unit Base Resistance (1 ksf = 47.9 kPa and 1 inch = 25.4 mm)

The bi-directional load applied during the load test translates to an average unit base resistance of slightly less than 460 ksf (22 MPa) acting over a 10-ft (3.05-m) diameter base (equivalent diameter of the 9-ft (2.74-m) diameter bottom plate, 1 ft (0.3 m) above the base, projected at 2:1 angle) as shown in Fig. 14. The average unit side resistance is slightly greater than 44 ksf (2.1 MPa) acting on an 11.5-ft (3.51-m) diameter (average value from SoniCaliper and 0.5 ft (0.15 m) larger than the nominal diameter), 22.3 ft (6.80 m) long socket (measured from the bottom plate to the tip of permanent casing) as shown in Fig. 15. Note that these values were mobilized at very small displacements and do not represent the nominal strength values.

The average q_u of the rock beneath the base of the test shaft is about 12,000 psi (83 MPa) and the maximum measured unit base resistance in the load test was about 460 ksf (22 MPa). The test data shown on Fig. 14 suggest that the maximum applied pressure was well below the nominal unit base resistance. Based on a relationship between the nominal unit base resistance, q_{bN} , and the compressive strength of the rock, q_u , using equation (2):

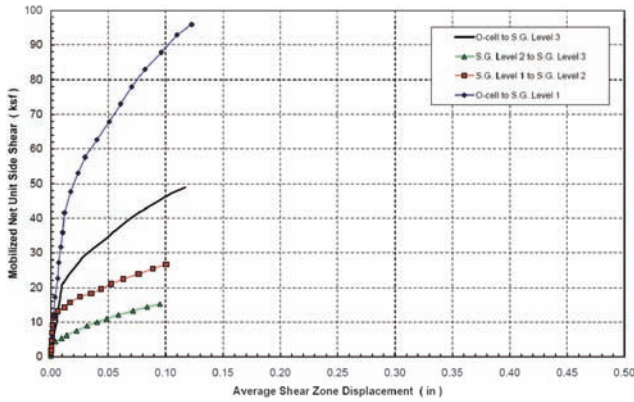
[FIG. 15] Unit Side Resistance (1 ksf = 47.9 kPa and 1 inch = 25.4 mm)

The measured side resistance was less than the nominal strength value, as indicated by the data provided on Fig. 15. Therefore, any back-correlation using these measured values represents a lower bound value, since the test was limited by the capacity of the system to mobilize additional side resistance. In addition, the strength of the rock substantially exceeds the 5,000 psi (34 MPa) compressive strength of the concrete used for the drilled shaft. Traditionally, the lesser of the compressive strength of either the concrete or rock is used for design.

Based on the mobilized average unit side resistance, f_s , of approximately 44 ksf (2.1 MPa) and compressive strength, q_u , of 5,000 psi (34.5 MPa), the constant, C , from equation (1) is back-calculated to be 1.1. Using the average q_u of the rock along the length of the sockets of 24,000 psi (165 MPa), the constant, C , from equation (1) is back-calculated to be 0.5, which generally agrees with other load tests in hard limestone (Brown, 2008).

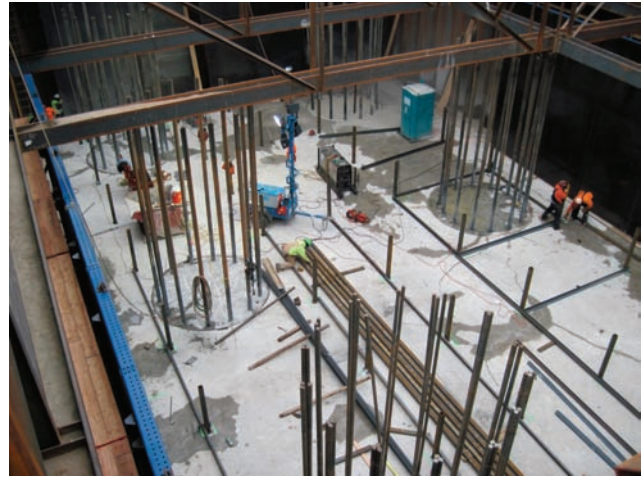
[FIG. 16] Construction of the Pylon Foundation within Coffercell at Top of Seal

The 25 ft (7.6 m) thick footing was constructed within a sheet pile coffercell, and the soils within the coffercell were excavated to a depth of 15 ft (4.6 m) below the bottom of the footing to construct an unreinforced concrete seal slab. After tremie placement of the seal, the coffercell was dewatered to expose the top of the drilled shafts and allow the chipping of the top of the shaft to remove laitance and provide placement of reinforcement for the footing. A photo of the coffercell after dewatering is provided in Fig. 16.
