**ADSC  
EXPO 2012  
SAN ANTONIO | TEXAS  
MARCH 14-17**

**ADSC RESEARCH PROJECT UPDATE:  
ROCK SOCKETS IN THE  
SOUTHEASTERN U.S.**

**W. Robert Thompson, III, P.E., D.GE  
Dan Brown and Associates, PC  
Montgomery, Alabama**

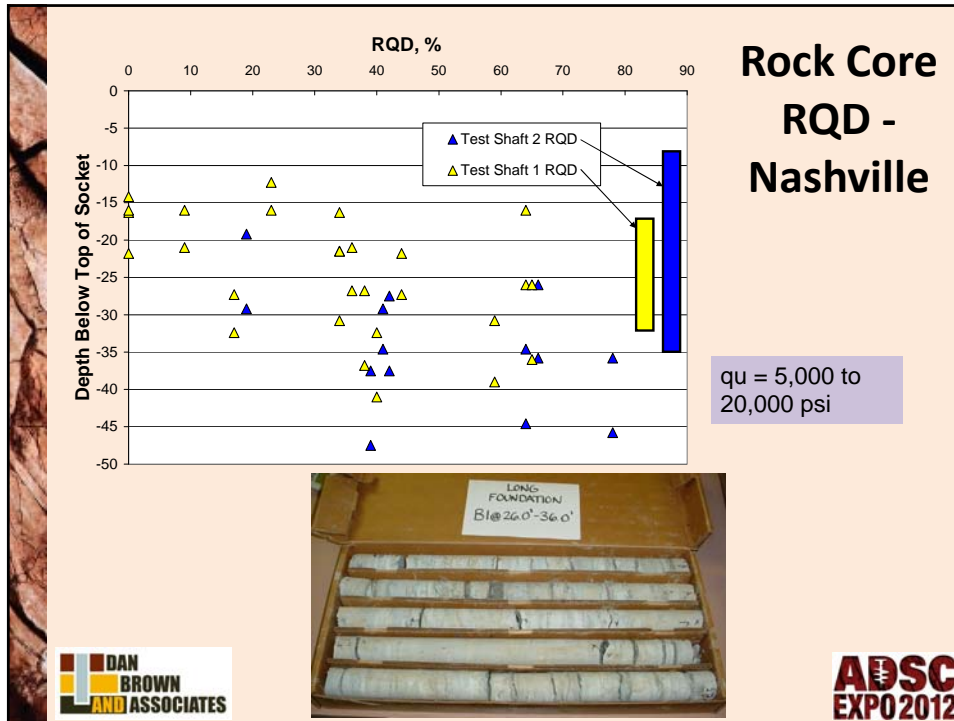
## Nashville Site

- ### Construction - Nashville
- 48in core barrel to excavate limestone sockets (16ft)
  - Mechanical cleaning only
  - Inspectors consensus:
    - TS 1 had 3in to 4in soil seam 19in below base
      - Shaft should have been extended
    - TS 2 no significant seams
      - Typical conditions sought
    - Both shafts needed additional cleaning
  - Significant concrete overrun in TS 2

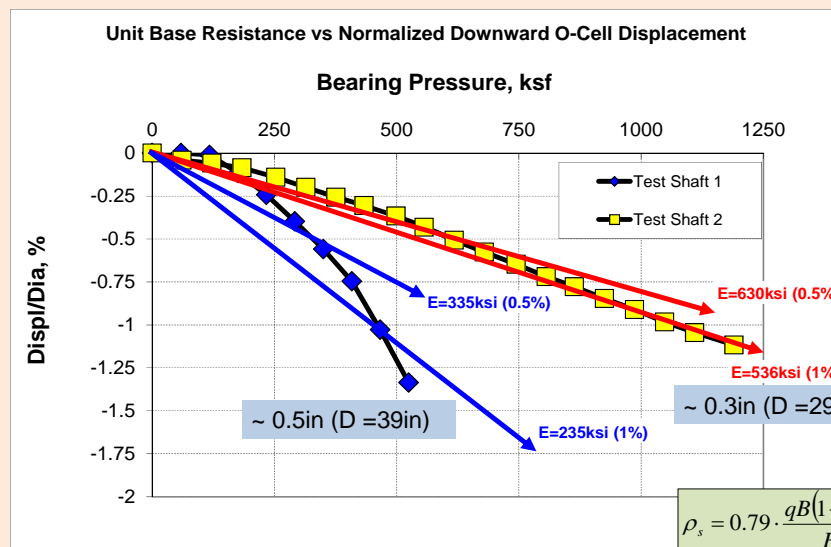
## Unit Base Resistance - Nashville

- Displacements about 1% of loaded area  
(B = 39in for TS 1; B = 29in for TS 2)
- Inspections indicated soil seam 19in below TS 1  
(10% of B approx. 0.5B below shaft base )
- Maximum unit base resistance
  - TS 1 = 500 ksf
  - TS 2 = 1250 ksf

- **“Sound Rock”**: conditions similar to Test Shaft 2
  - 1 or 2 small seams < ½ inch thick
  - Allowable unit base resistance = 500ksf
- **“Fair Rock”**: conditions similar to Test Shaft 1
  - soil-filled seams up to 10%B, at depths > ½ B
  - Allowable unit base resistance = 200 ksf
- **Displacement approx. 0.5%B**  
(1/4 to 3/8 inch for B = 4 to 6 ft)

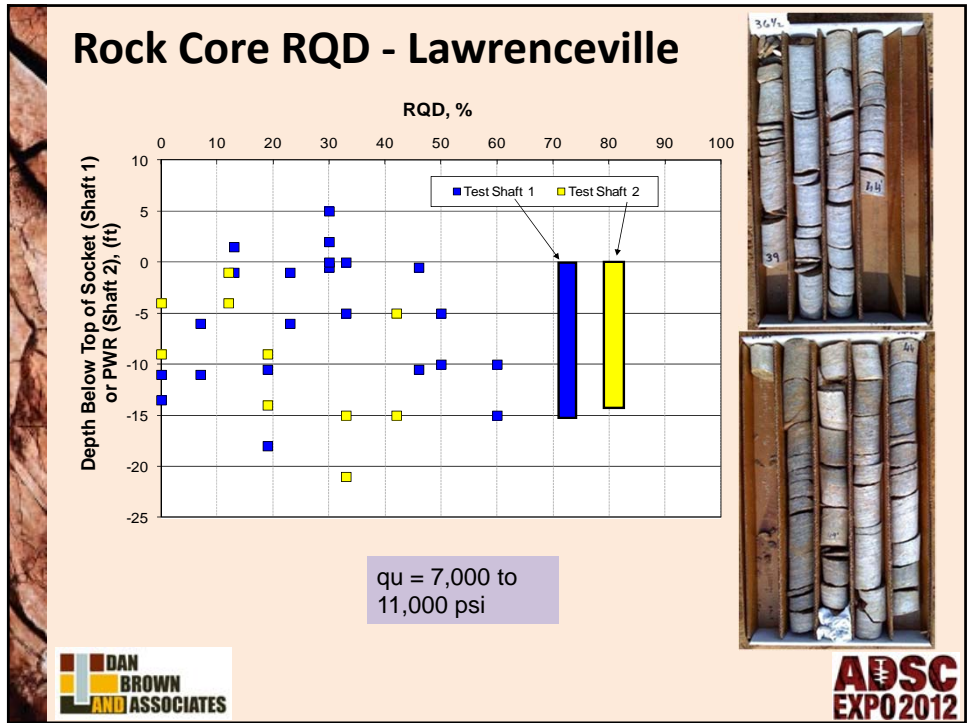
## Construction - Lawrenceville

- **TS 1 – Test side and base resistance of 40.5in rock socket**
  - Started with core barrel, completed with rock auger
  - Penetration = 4 to 6.5in/min – not “Rock Auger Refusal”
- **TS 2 – Test base resistance at “Rock Auger Refusal” with 66in socket and 19in O-cell**
  - Drilled with rock auger
  - Two distinct zones of PWR
  - Penetration = 3in/5min – not “Rock Auger Refusal”
