Foundations for the Bridge at Pitkins Curve

John P. Turner¹, John D. Duffy², Reid Buell³, and Xing Zheng³

A case history is presented on the design, construction, testing, and performance of drilled shafts for a bridge located at a difficult site on Highway 1 along California's Big Sur Coast. The purpose of the bridge is to traverse a landslide that has been a long-term maintenance challenge for Caltrans. The site is underlain by rock of the Franciscan Formation and consists of metamorphosed siltstone and sandstone with inclusions of metabasalt. The rock is highly folded and fractured, difficult to sample in some locations, and exhibits wide variations in strength and quality. Construction challenges included the need to place bridge piers on a steep slope just outside the limits of active sliding and installation of drilled shafts into highly fractured rock prone to caving. The presence of perched water tables caused highly variable and unpredictable inflow of water to drilled shaft excavations. This paper describes how these constructability issues were addressed and how they influenced the selection and design of the foundations. This paper demonstrates a rational approach to

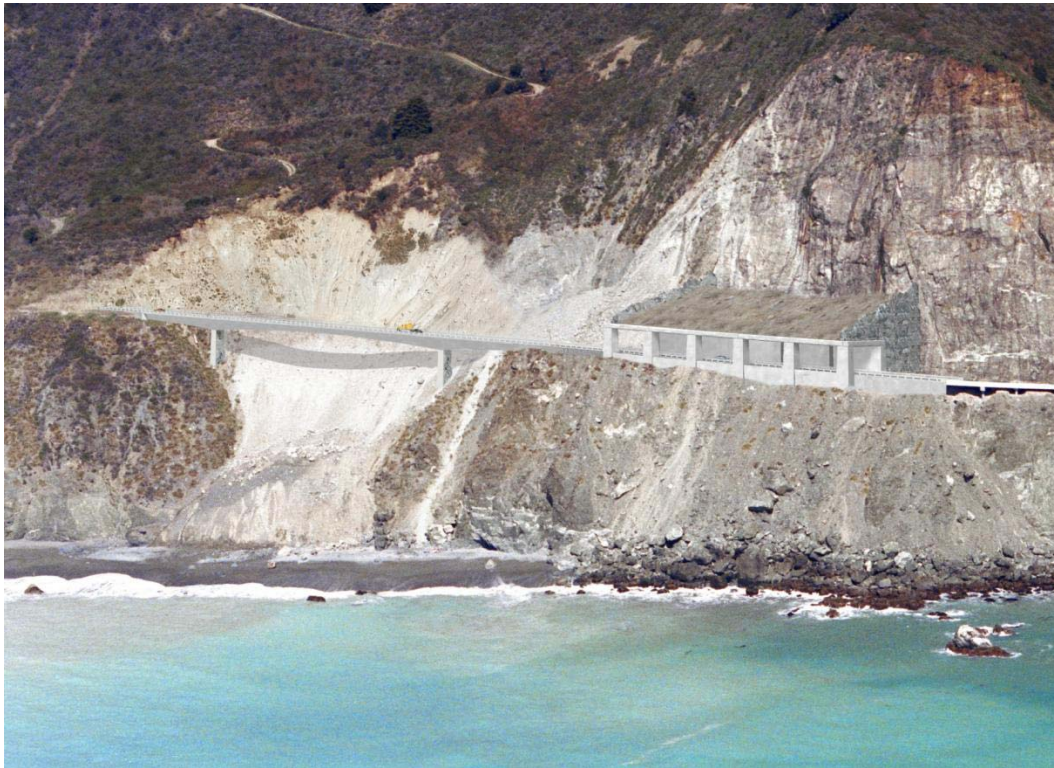
Figure 2. Proposed Bridge and Rock Shed at Pitkins Curve/Rain Rocks.

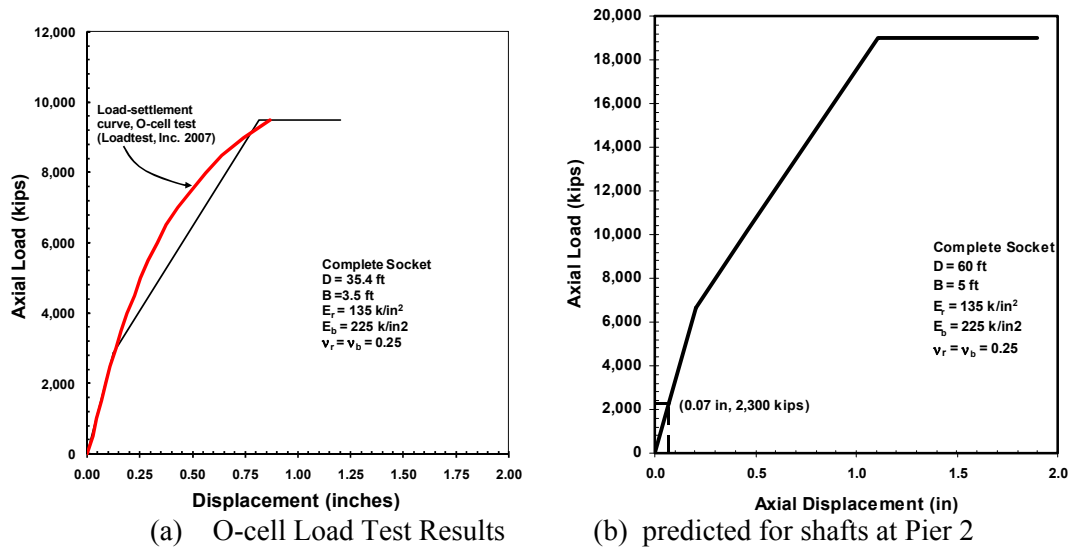
Service limit state design was based on a tolerable settlement for individual shafts of ½ inch under a nominal axial force of 2,300 kips, as established by the bridge structural engineer. A load-displacement model was developed from the O-cell load test results, as described by the authors in an earlier paper (Turner et al., 2009). A simplified model of rock socket load-settlement behavior given by Kulhawy and Carter (1992) is fit to the measured axial load displacement curve from the load test through trial values of the rock mass elastic and strength properties. Where borings verify that the rock mass has similar lithology, strength, and discontinuity characteristics, the analysis can then be used to evaluate load-deformation behavior of trial designs (Turner, 2006). Figure 3a shows the O-cell curve and the resulting modeled curve, while Figure 3b shows the curve extrapolated to the conditions at Pier 2. For an axial compression load of 2,300 kips, the predicted displacement is approximately 0.07 inches and the shaft response is in the linear elastic range. By

Figure 3. O-Cell Equivalent Top-Load Settlement Curve and Modeled Curve.

this analysis, the proposed trial design easily satisfies the service limit state criterion that limits settlement to $\frac{1}{2}$ inch. The final shaft dimensions are governed by strength and extreme event load considerations and not by the axial settlement criterion.

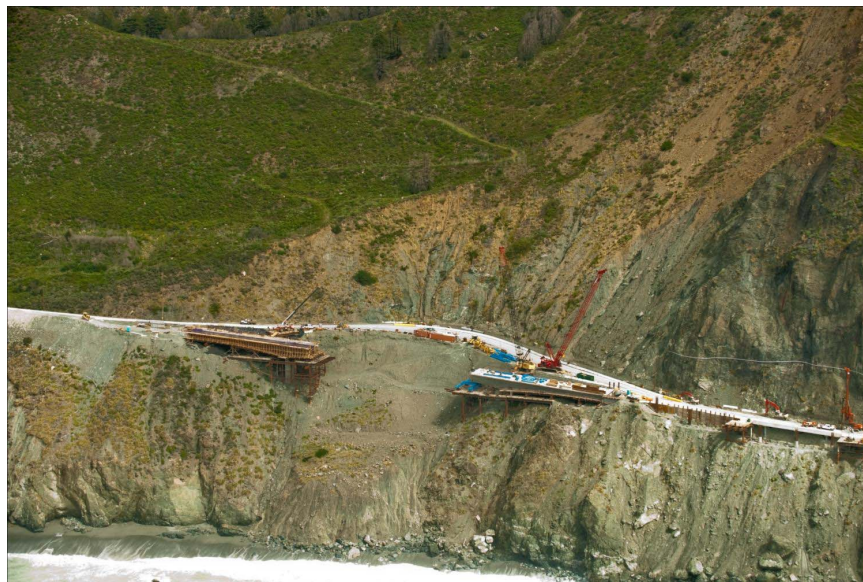
Construction began in January of 2010 with the erection of trestles to support construction equipment for drilled shaft construction. Two trestles were erected, one from the north abutment and one from the south, as shown in Figure 4. Trestles are supported on 24-inch diameter piles driven into rock using a downhole hammer.

Figure 4. Trestles extending from north and south abutments.

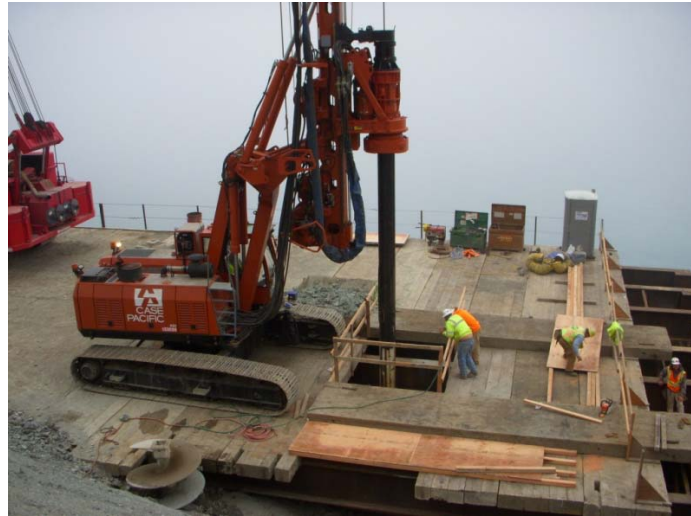
At each pier location, a temporary shored excavation was extended to the top of rock. A group of four 5-ft diameter drilled shafts was constructed inside each excavation by drilling from the trestle, as shown in Figure 5.

Figure 5. Drilled shaft excavation from south trestle.

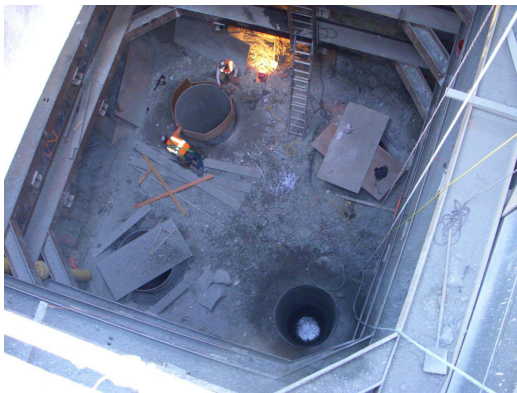
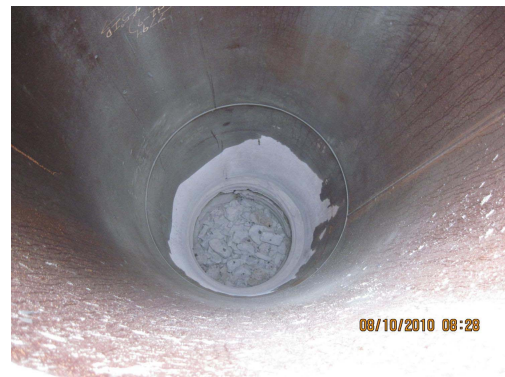
Difficulties encountered during drilled shaft construction were those anticipated during the planning phases, namely caving of fractured rock and high inflow of water upon encountering pockets of perched water. The contractor addressed these difficult conditions by first drilling into the caving material with a slightly oversized auger and removing as much material as possible. A low strength concrete mix was then added to the bottom of the excavation and mixed with the caved materials. When the mix was sufficiently hardened, the socket was re-drilled to the design diameter, essentially into the cement-stabilized material. This technique made it possible to extend the shafts through the caving zones to the target tip elevations. Figure 6a shows conditions at the bottom of the shored excavation for construction of the foundations at Pier 2, while Figure 6b shows the excavation after cement stabilization of one of the caving zones.

Figure 6. (a) Drilled shaft construction inside shored excavation, (b) cement-stabilized excavation in caving rock.
