ZEN AND THE ART OF DRILLED SHAFT CONSTRUCTION: THE PURSUIT OF QUALITY

Dan A. Brown, P.E., M. ASCE

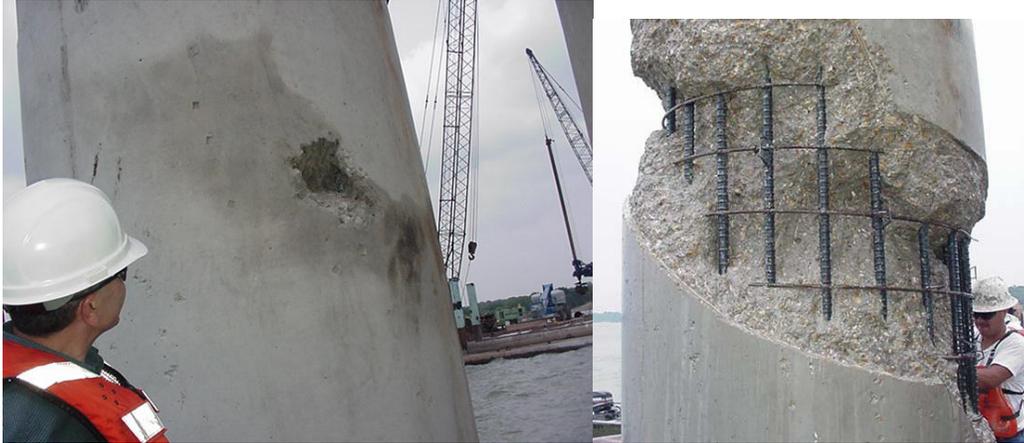
Upon removal of the forms, the inspectors noted the presence of pockets of weak concrete which could be chipped away quite easily with a hammer. These pockets appeared to be a weak, cemented grout-like material that had no aggregates within it. Photographs of this material, along with a typical pattern after the weak material had been chipped away, are provided on Figure 1.

Figure 1 Surface flaws in concrete (left), after removal for repair (right)

At first it was suspected that either bleed water was contributing to this problem, or the contractor's removal forms were somehow not sealing and water was mixing with concrete during placement. However, further investigation revealed that the concrete mix did not maintain sufficient workability for the duration of the pour during the hot summer months. As tremie placement of concrete continued, the tremie would be lifted from the bottom of the shaft but always maintaining the base of the tremie at least 2 m below the surface of the concrete. As the initial charge of concrete (now riding on top, above the tremie) started to lose workability, the freshly placed concrete entering the shaft through the tremie below the surface of this now-stiff concrete tended to erupt through this old, stiff concrete like a volcano rather than lifting the entire surface upwards. As this fresh, fluid concrete vents through the surface of older, less fluid concrete, the latent cement/water mixture on the surface of the rising concrete plug flowed to the lower surface outside the cage and became trapped below the fresh concrete. This flow pattern was visibly revealed in one of the shafts when the contractor pumped off the water above the concrete after the concrete was well up into the casing, and the placement continued using the tremie. The inspector reported the "volcano" of fresh concrete with the lateral displacement and subsequent trapping of latent water/concrete mixture that was present on top of the old concrete.

It is critical that the concrete mix have sufficient retarder that the concrete maintain its workability for the duration of the pour. In this case, that was at least 6 hours from the time of batching because of the slow delivery of concrete to the foundation location.

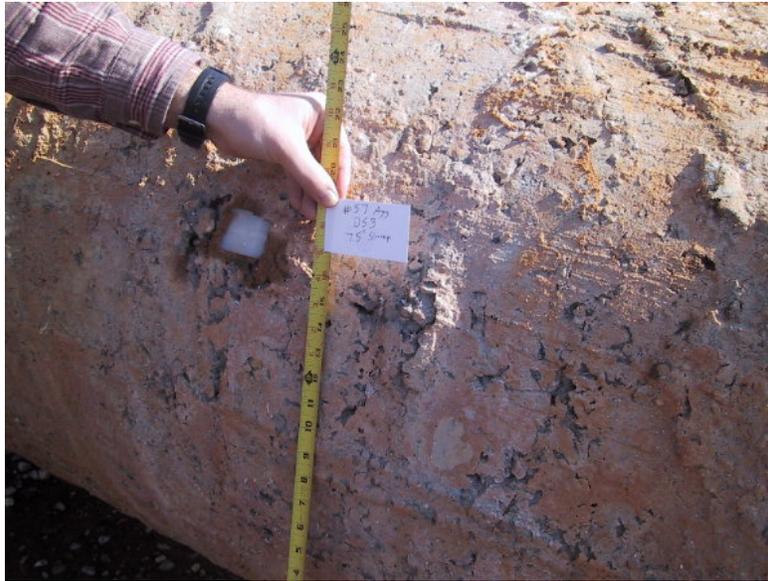
Figure 2 Surface of the Shaft with #57 Stone

Subsequently, the shafts were exhumed and the surface of the concrete examined (see Figure 2). The surface texture of the shaft with the pea gravel aggregate appeared less permeable. There was no trapped debris, since both shafts were constructed using tremie placement in the dry.

Concrete does not flow upward above the tremie as a nice homogeneous mass. Rather, the surface is a rolling, boiling three dimensional thing which could easily entrap any debris which resides on top and which can build up a head differential between the interior and the exterior of the rebar cage.

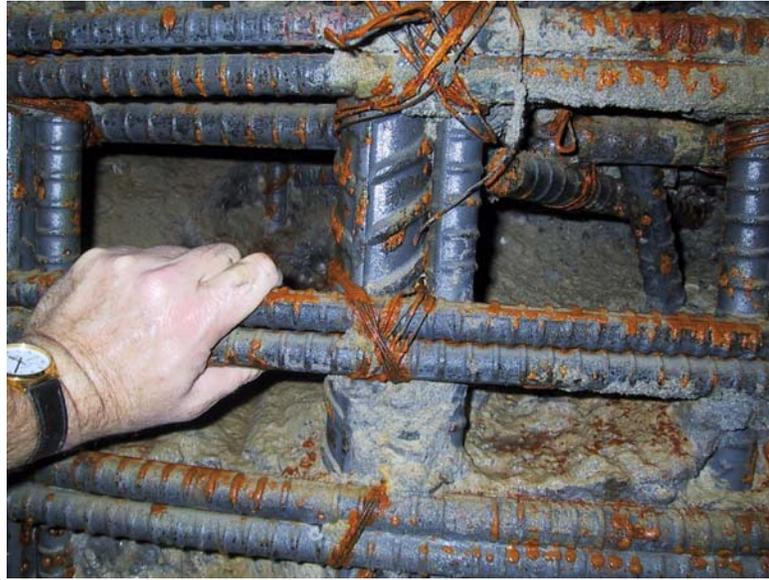
Integrity testing indicated the presence of voids around the perimeter of several shafts. Access shafts were constructed to examine the problem and pockets of sand were discovered within the zone where the two cages overlap, as illustrated on Figure 3.

Figure 3 Defect in Shaft with Double Rebar Cages

A simple cage with considerations of constructability is needed in order to make drilled shafts less vulnerable to defects and to promote quality construction. A permanent casing socketed into the underlying rock could also have reduced the likelihood of defects in this case because the hole could have been kept dry, although the difficulty with the rebar and concrete would still be present. The concrete mix in the case of severely congested rebar should incorporate good flow characteristics with small rounded gravel aggregates.

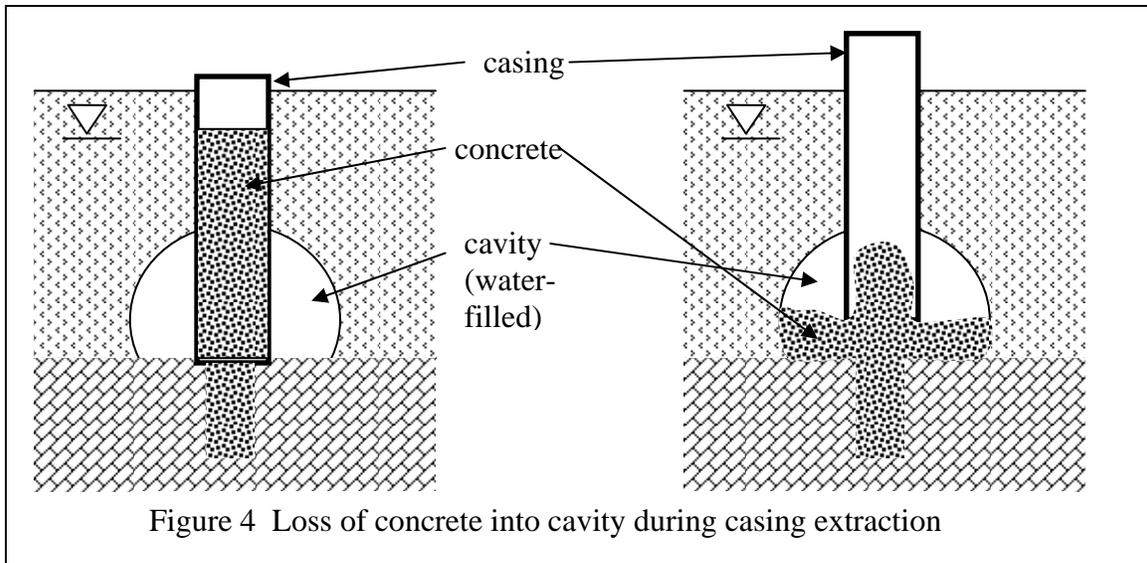
A drilled shaft was installed at a site in Florida by vibro-driving a casing through the overlying water-bearing sand into the top of limerock. The shaft excavation was completed within the limerock and concrete placed to near the top of the casing. The casing was pulled upwards approximately 0.6 m (2 feet) and the concrete level within the casing dropped to near the bottom of the casing. Although the contractor attempted to

Figure 4 Loss of concrete into cavity during casing extraction

Although the contractor had used care to avoid causing a cavity around the casing during excavation, the limerock in this area had natural cavities formed by solution activity. These cavities tend to be found most often near the top of the formation. The contractor used good practice when withdrawing the casing only by a small amount so that additional concrete could be added to maintain the head, but the volume lost was so large that the head of concrete dropped below that of the surrounding groundwater and the structural integrity of the shaft was compromised.

Because this cavity was a natural occurrence, the design of the shaft needs to accommodate the possibility of large cavities as a construction consideration. This condition would be more effectively handled with the use of a permanent casing.

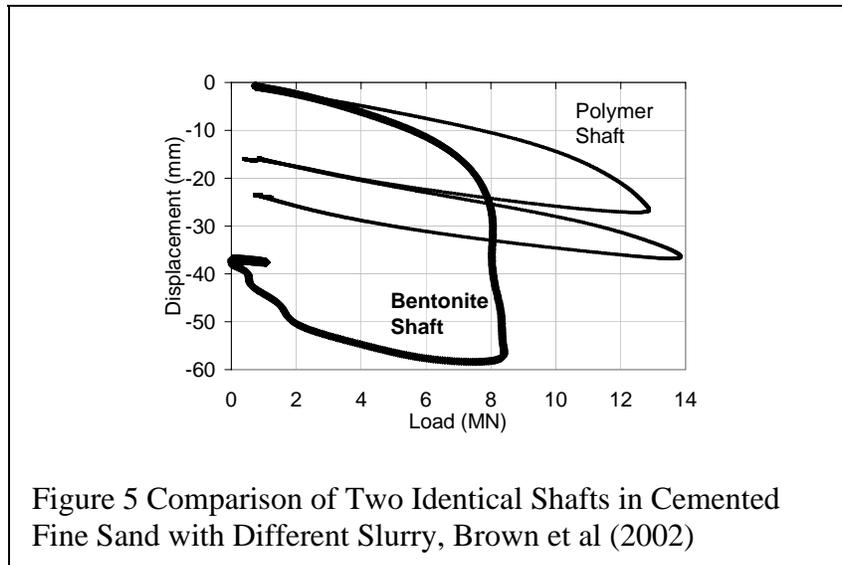
Several recent comparative tests have demonstrated that polymer slurries can significantly outperform bentonite in terms of side shearing resistance, as illustrated by the data on Figure 5 (Brown et al, 2002). This trend appears most notably in granular soils where there is some fluid loss into the surrounding formation and a bentonite filter cake is likely to form (Brown, 2002; Majano et al, 1994; Meyers, 1996). Where slurry is used in a relatively cohesive formation and there is little opportunity for fluid loss, differences in unit side shear have been insignificant (Camp et al, 2002). Although current design procedures do not generally delineate values used for design on the basis of construction technique, it is clear that the construction procedure used can have a major effect on performance. Where bentonite slurry is used within the bearing formation, the quality of the bond is enhanced by minimizing the exposure time.

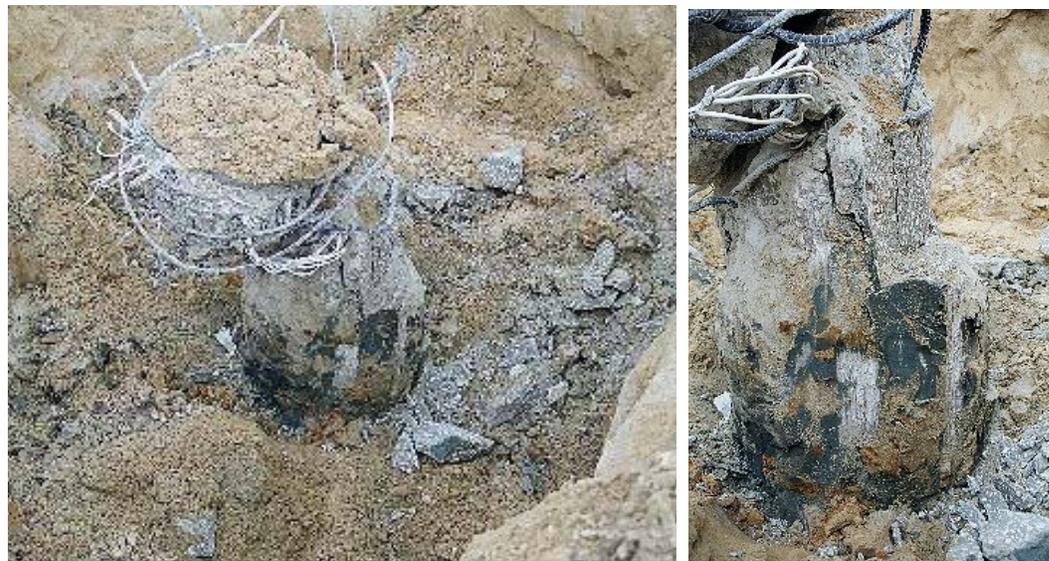
When the load testing was performed, the shaft failed suddenly at approximately 150% of the design load. Strain gauges within the shaft suggested that very little load was reaching the lower portions of the limestone socket. Upon excavating the upper 2 m of the shaft (6 feet), the shaft was observed to have suffered structural failure at a load corresponding to less than 14 Mpa (2000 psi) over the theoretical cross sectional area of the shaft (see Figure 5). The shaft was cut off cleanly at about 2 m below grade, a new top formed, and the load test was successfully carried out to over 2 times the design load without achieving failure (either geotechnical or structural).

Figure 6 Broken Top of Shaft after Load Test

The shaft was constructed with a false sense of security regarding concrete placement because of the casing and the stable limerock formation. Even though only water was used during drilling, the properties of the resulting slurry are important because of the potential effect on the concrete during placement. It appears that the concrete integrity was compromised within the upper 2 m of the shaft, resulting in structural failure when loaded to high stresses. The lesson learned from this example is that any wet pour has the potential to impact concrete integrity and the drilling fluid must be clean and the concrete must have good workability.
