Drilled Shaft Foundations for the Hurricane Deck Bridge (A RCD Story)

Introduction

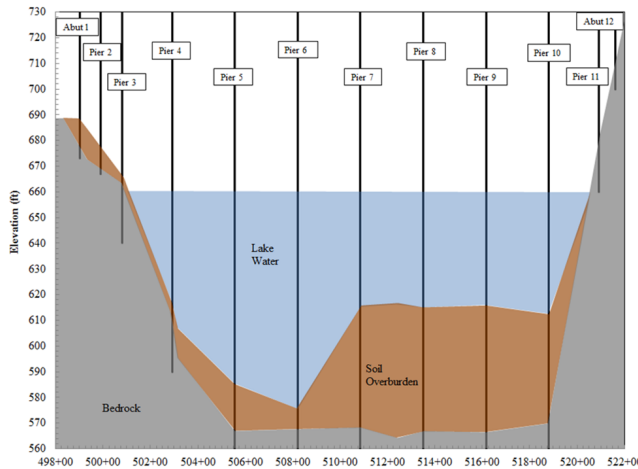
Fig 2: Subsurface Profile.

The diameter was controlled by lateral considerations and the relative large unsupported length between the mudline and the waterline strut. The submerged overburden soil was soft and provided little lateral resistance. A schematic of the subsurface profile longitudinal with the bridge is provided in Figure 2 with the bent locations superimposed. At some locations, the water is 80ft (24.38m) deep with only about 10ft (3.04m) of soil above bedrock. Due to the relatively large unsupported shaft length, the structural engineer concluded and specified that the maximum allowable plumbness tolerance was one percent.

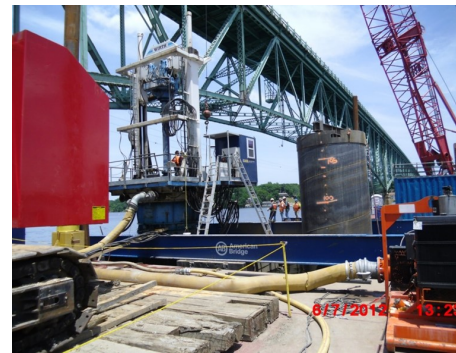
Fig 3a: Reverse Circulation Drill Rig

Fig 3b: Reverse Circulation Drill Rig Foundation drilled the rock sockets with an RCD rig. The rig was mounted to the top of the permanent casing as shown in Figures 3a and 3b and the excavation was advance using a full-face cutter assembly as shown in Figure 4.

The configuration of drill rig and cutting tool combined to make what was essentially a large plumb bob. This proved beneficial in achieving the maximum one percent vertical tolerance specified in the construction documents.
