**CASE HISTORY:
UTILIZING LOAD TEST DATA TO VALUE ENGINEER DRILLED SHAFT
FOUNDATIONS**

ABSTRACT

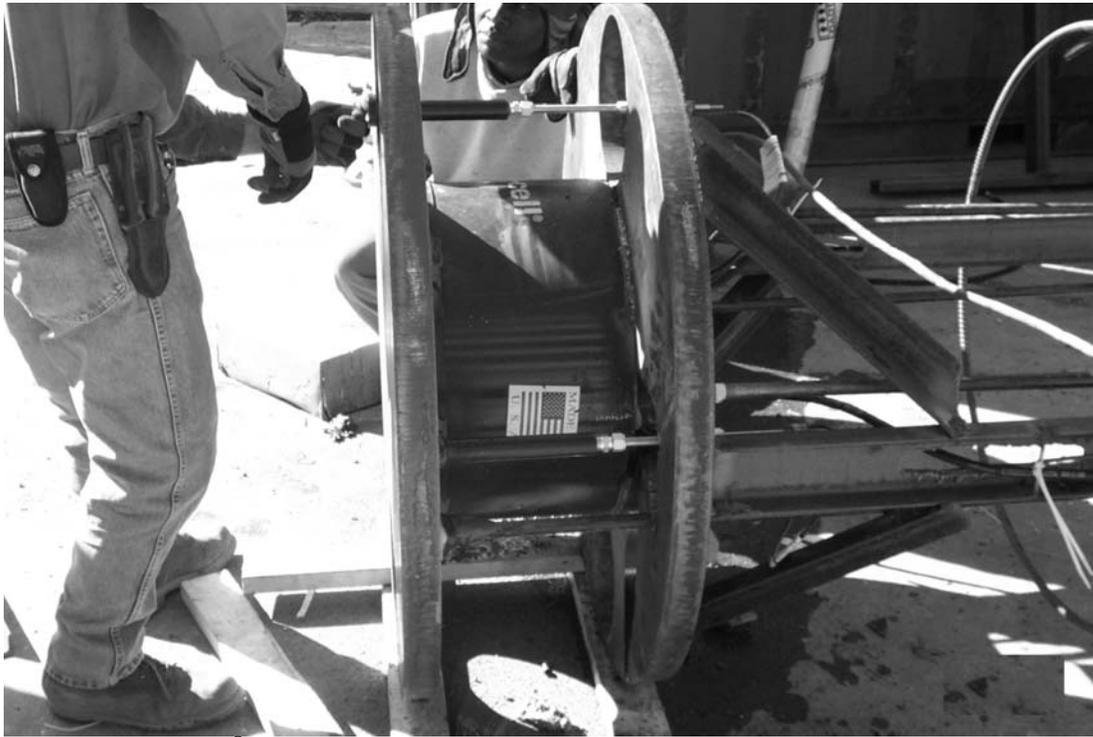
Figure 1 – O-cell[®] being prepared for installation into drilled shaft.

LOADTEST, Inc. (ADSC Associate Member) performed the O-cell[®] test on a 48-inch (1,220 mm) diameter shaft. This shaft was a non-production shaft installed solely for the load test. The load cell used for the test is shown in Figure 1. The shaft was drilled to a depth of 59.8 feet (18.21 meter) and socketed 2 feet (0.61 m) into weathered rock. The shaft was constructed in the wet using polymer slurry. The shaft excavation was allowed to sit over night. On the following day, the bottom of the shaft was cleaned with a 40-inch (1,016 mm) cleaning bucket. The concrete was placed in the bottom of the shaft by tremie pipe, which extended past the O-cell[®] until the top of the concrete reached the cut-off elevation.

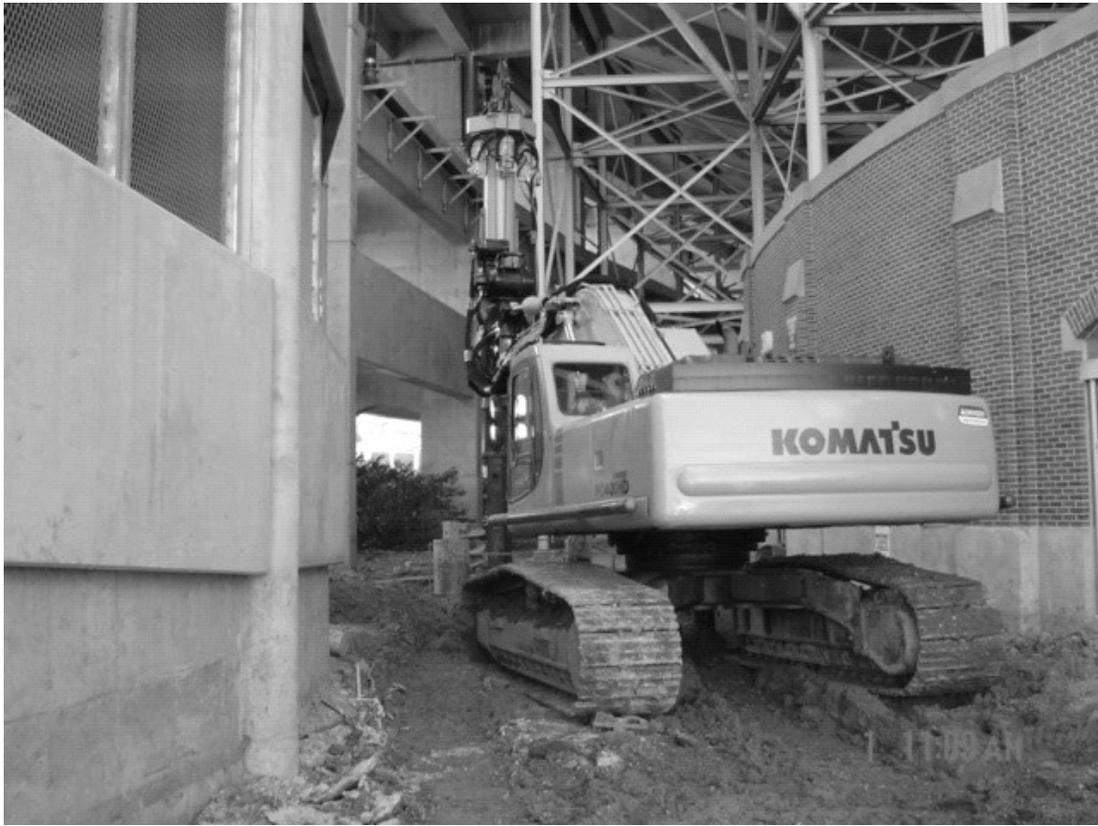
Figure 2 – Lo-Drill operating in confined work area.
